Intersection ID: 10132	Main Street: CAMPUS_ST	Cross Street: MILL_RD	Location:	NW
ADA ID: 781DBC4AD185	Ramp Type: PerpDiag	Initial Pass/Fail: Fail	Overall Compliance: No	Severity Score: 22.5

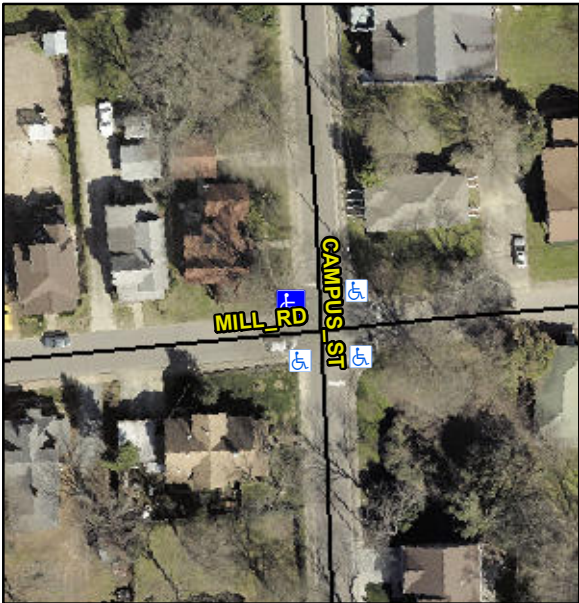
Possible Solutions:		Compliance			Description			Data	
	Remove & Replace Curb Ramp With Two New Directional Ramps or Equivalent.		N/A	Ramp Length (in)	31.0	No	Ramp Slope (%)	8.7		
			No	Ramp Width (in)	43.0	No	Ramp XSlope (%)	3.3		
			N/A	Flare Type LT	N/A	N/A	Flare Type RT	N/A		
			N/A	Flare Slope LT (%)	N/A	N/A	Flare Slope RT (%)	N/A		
			N/A	Flare Traversable LT?	N/A	N/A	Flare Traversable RT?	N/A		
			N/A	Landing Length (in)	N/A	N/A	DWS Provided?	N/A		
			N/A	Landing Width (in)	N/A	N/A	DWS Contrast?	N/A		
			N/A	Landing Slope (%)	N/A	N/A	DWS Length (in)	N/A		
			N/A	Landing X Slope (%)	N/A	N/A	DWS Full Width?	N/A		
Surveyor Notes:		N/A	Landing Curb? (Y/N)	N/A	N/A	DWS Offset (in)	N/A			
PROW/ADA:		N/A	Shared Landing?	N/A	N/A	Gutter Slope (%)	N/A			
Not Found, R304.5.1, R304.2.2, R304.5.3		N/A	Gutter Ponding?	N/A	N/A	Gutter X Slope (%)	N/A

N/A	Gutter Lip Ht (in)	N/A	N/A	Painted X Walk2?	No			
		N/A	Painted X Walk1?	No	N/A	X Walk 2 Direction	To E			
		N/A	X Walk 1 Direction	To S	N/A	X Walk 2 Width (in)	N/A			
		N/A	X Walk 1 Width (in)	N/A	N/A	X Walk 2 Slope (%)	0.8			
		N/A	X Walk 1 Slope (%)	5.5	N/A	X Walk 2 X Slope (%)	2.8			
		N/A	X Walk 1 X Slope (%)	2.7	N/A	Ramp inside XWalk2?	N/A			
Street 1 Name		MILL RD	N/A	Ramp inside XWalk1?	N/A	N/A	Clear Space?	N/A		
Stop Condition-Street 2		StopSign	N/A	Road Slope (%)	3.1	N/A	Clear Space to XWalk (in)	N/A		
Street 2 Name		CAMPUS ST	N/A	Road X Slope (%)	2.0	N/A	Storm Grate/Utility Hazard?	N/A		
Stop Condition-Street 1		StopSign	N/A	Any Obstructions?	N/A	N/A	Storm Grate/Utility Type	N/A		
Total Cost:		\$ 3200.00	N/A	Obstruction Type	N/A	Yes	Surface Condition? (G/P)	Good
