Access Compliance Report Public Rights-of-Way (Curb Ramps)

Intersection ID: 18125Main Street: BRANDYWINE_RDCross Street: CHELSEA_DRLocation:NWADA ID: 782389337A16Ramp Type: BlendTrans2Initial Pass/Fail: FailOverall Compliance: NoSeverity Score:10

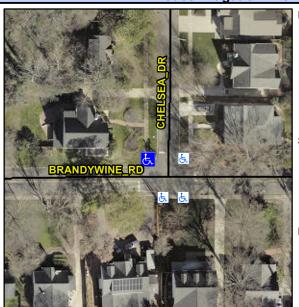
ASP LIP 0.5

PROW/ADA:

R304.5.1, R304.5.3

Compliance Description Data Compliance Description Data Ramp Length (in) Yes BlendTrans Slope (%) N/A 91.0 3.5 No No Ramp Width (in) 46.0 BlendTrans XSlope (%) 2.5 N/A N/A Flare Type LT N/A Flare Type RT N/A N/A Flare Slope LT (%) N/A N/A Flare Slope RT (%) N/A N/A Flare Traversable LT? N/A N/A Flare Traversable RT? N/A N/A Landing Length (in) N/A N/A DWS Provided? N/A N/A Landing Width (in) N/A N/A **DWS Contrast?** N/A N/A N/A N/A Landing Slope (%) DWS Length (in) N/A N/A Landing X Slope (%) N/A N/A DWS Full Width? N/A N/A Landing Curb? (Y/N) N/A N/A DWS Offset (in) N/A N/A N/A Shared Landing? N/A **Gutter Ponding?** N/A N/A Gutter Slope (%) N/A N/A Gutter Lip Ht (in) N/A N/A Gutter X Slope (%) N/A N/A Painted X Walk1? No N/A Painted X Walk2? No X Walk 1 Direction To S X Walk 2 Direction To E N/A X Walk 1 Width (in) X Walk 2 Width (in) N/A X Walk 1 Slope (%) 5.7 X Walk 2 Slope (%) 4.7 X Walk 1 X Slope (%) 3.5 X Walk 2 X Slope (%) 5.6 N/A N/A Ramp inside XWalk2? N/A N/A Ramp inside XWalk1? Road Slope (%) 2.6 Clear Space? N/A Road X Slope (%) 7.7 N/A Clear Space to XWalk (in) N/A N/A N/A N/A Any Obstructions? Storm Grate/Utility Hazard? N/A **Obstruction Type** Storm Grate/Utility Type N/A N/A Yes Surface Condition? (G/P) Good N/A Curb Slope (%) 2.7

BRANDYWINE RD StopSign CHELSEA DR StopSign Possible Solutions:

Remove & Replace Curb Ramp With
Two New Directional Ramps or
Equivalent.
