# Access Compliance Report

## Public Rights-of-Way

### (Curb Ramps)

Intersection ID: 27200	Main Street: ANNALEXA_LN	Cross Street: BALLANTYNE_COMMONS_PY	Location: NW
ADA ID: 782432D809B2	Ramp Type: Perp	Initial Pass/Fail: Fail	Overall Compliance: No
		Severity Score: 12.5

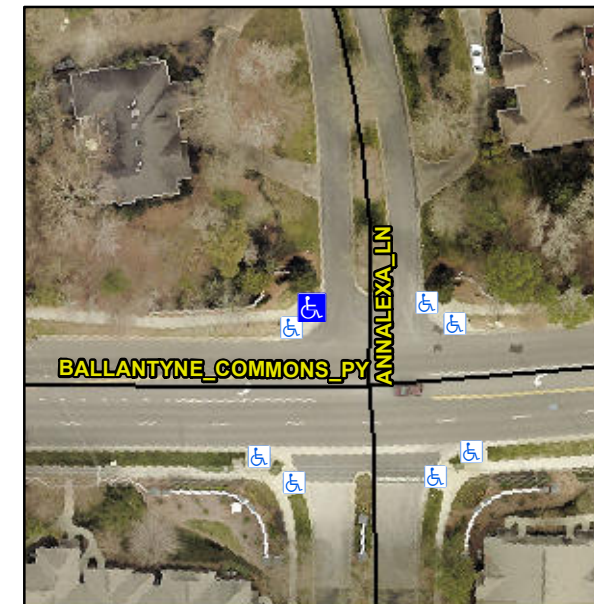
**Not Found, R304.2.2**

Compliance	Description	Data	Compliance	Description	Data
N/A	Ramp Length (in)	80.0	No	Ramp Slope (%)	9.3
Yes	Ramp Width (in)	48.0	Yes	Ramp XSlope (%)	0.9
N/A	Flare Type LT	N/A	N/A	Flare Type RT	N/A
N/A	Flare Slope LT (%)	N/A	N/A	Flare Slope RT (%)	N/A
N/A	Flare Traversable LT?	N/A	N/A	Flare Traversable RT?	N/A
N/A	Landing Length (in)	N/A	N/A	DWS Provided?	N/A
N/A	Landing Width (in)	N/A	N/A	DWS Contrast?	N/A
N/A	Landing Slope (%)	N/A	N/A	DWS Length (in)	N/A
N/A	Landing X Slope (%)	N/A	N/A	DWS Full Width?	N/A
N/A	Landing Curb? (Y/N)	N/A	N/A	DWS Offset (in)	N/A
N/A	Shared Landing?	N/A			
N/A	Gutter Ponding?	N/A	N/A	Gutter Slope (%)	N/A
N/A	Gutter Lip Ht (in)	N/A	N/A	Gutter X Slope (%)	N/A
N/A	Painted X Walk1?	No	N/A	Painted X Walk2?	N/A
	X Walk 1 Direction	To SE		X Walk 2 Direction	N/A
N/A	X Walk 1 Width (in)	N/A	N/A	X Walk 2 Width (in)	N/A
	X Walk 1 Slope (%)	1.6		X Walk 2 Slope (%)	N/A
	X Walk 1 X Slope (%)	0.9		X Walk 2 X Slope (%)	N/A

N/A	Ramp inside XWalk1?	N/A	N/A	Ramp inside XWalk2?	N/A
	Road Slope (%)	N/A	N/A	Clear Space?	N/A
	Road X Slope (%)	N/A	N/A	Clear Space to XWalk (in)	N/A
N/A	Any Obstructions?	N/A	N/A	Storm Grate/Utility Hazard?	N/A
	Obstruction Type			Storm Grate/Utility Type	
		N/A			N/A
			Yes	Surface Condition? (G/P)	Good

**Remove & Replace Entire Ramp.**

Total Cost: \$ 1850.00
