Access Compliance Report

Public Rights-of-Way

(Curb Ramps)

Intersection ID: 2874	Main Street: HORNBEAM_CT	Cross Street: LADY_BANK_DR	Location: NE
ADA ID: 7829294368AB	Ramp Type: BlendTrans1	Initial Pass/Fail: Fail	Overall Compliance: No
		Severity Score: 8.75

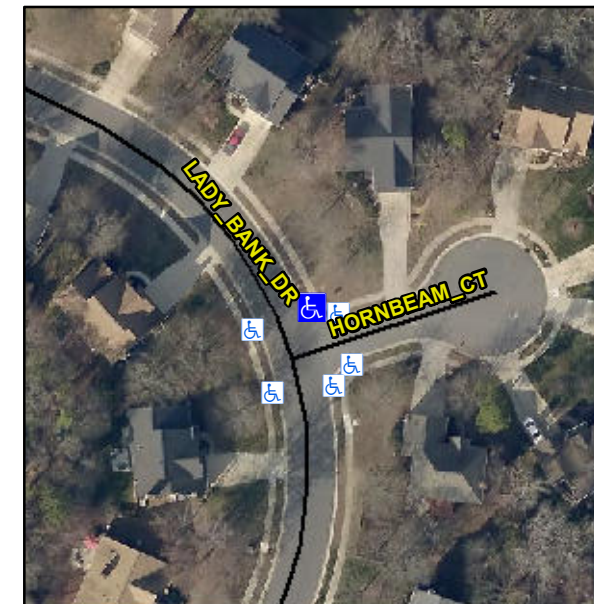
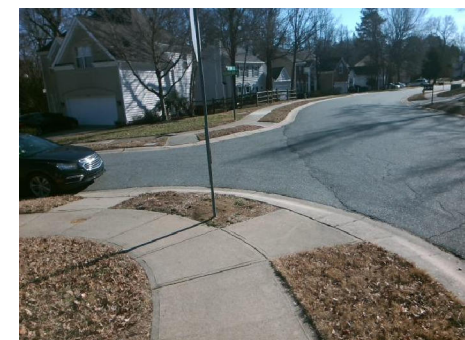
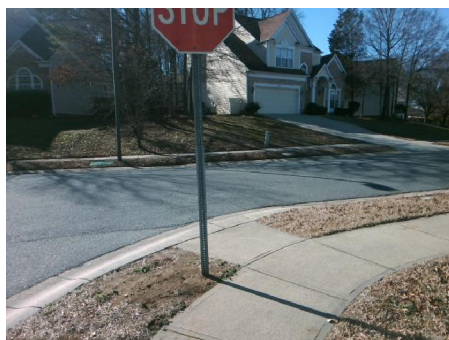
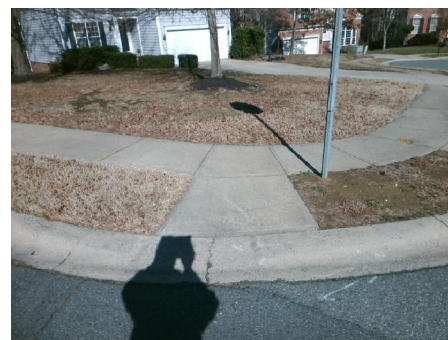
Compliance	Description	Data	Compliance	Description	Data
N/A	Ramp Length (in)	49.0	Yes	BlendTrans Slope (%)	2.9
No	Ramp Width (in)	47.0	Yes	BlendTrans XSlope (%)	1.0
N/A	Flare Type LT	N/A	N/A	Flare Type RT	N/A
N/A	Flare Slope LT (%)	N/A	N/A	Flare Slope RT (%)	N/A
N/A	Flare Traversable LT?	N/A	N/A	Flare Traversable RT?	N/A
N/A	Landing Length (in)	N/A	N/A	DWS Provided?	N/A
N/A	Landing Width (in)	N/A	N/A	DWS Contrast?	N/A
N/A	Landing Slope (%)	N/A	N/A	DWS Length (in)	N/A
N/A	Landing X Slope (%)	N/A	N/A	DWS Full Width?	N/A
N/A	Landing Curb? (Y/N)	N/A	N/A	DWS Offset (in)	N/A
N/A	Shared Landing?	N/A			
N/A	Gutter Ponding?	N/A	N/A	Gutter Slope (%)	N/A
N/A	Gutter Lip Ht (in)	N/A	N/A	Gutter X Slope (%)	N/A
N/A	Painted X Walk1?	No	N/A	Painted X Walk2?	N/A
	X Walk 1 Direction	To SW		X Walk 2 Direction	N/A
	X Walk 1 Width (in)	N/A		X Walk 2 Width (in)	N/A
	X Walk 1 Slope (%)	1.5		X Walk 2 Slope (%)	N/A
	X Walk 1 X Slope (%)	0.8		X Walk 2 X Slope (%)	N/A

N/A	Ramp inside XWalk1?	N/A	N/A	Ramp inside XWalk2?	N/A
	Road Slope (%)	0.8		Clear Space?	N/A
	Road X Slope (%)	1.5	N/A	Clear Space to XWalk (in)	N/A
N/A	Any Obstructions?	N/A	N/A	Storm Grate/Utility Hazard?	N/A
	Obstruction Type			Storm Grate/Utility Type	
		N/A			N/A
			Yes	Surface Condition? (G/P)	Good
			N/A	Curb Slope (%)	1.3

Remove & Replace Curb Ramp With Two New Directional Ramps or Equivalent.

R304.5.1
