Access Compliance Report

Public Rights-of-Way

(Curb Ramps)

Intersection ID: 48857	Main Street: FENCELINE_DR	Cross Street: GREENFINCH_DR	Location: SW
ADA ID: 783A4BDD7A73	Ramp Type: Perp	Initial Pass/Fail: Fail	Overall Compliance: No
Severity Score: 21.25			
Codes/Mitigation Info/Possible Solution		Field Measurements/Component Compliance

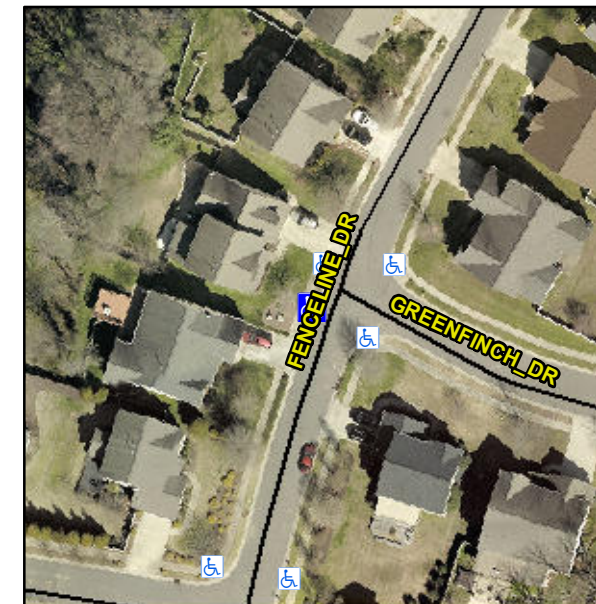
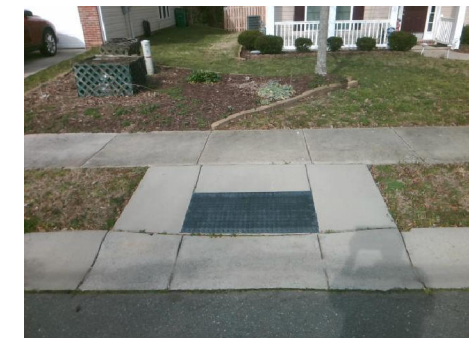
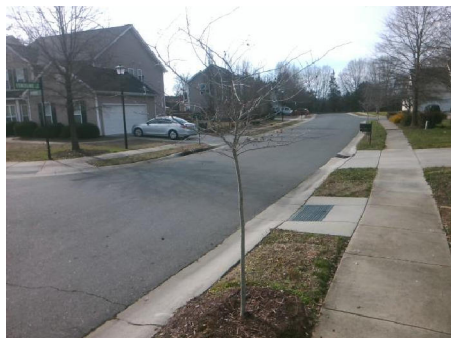
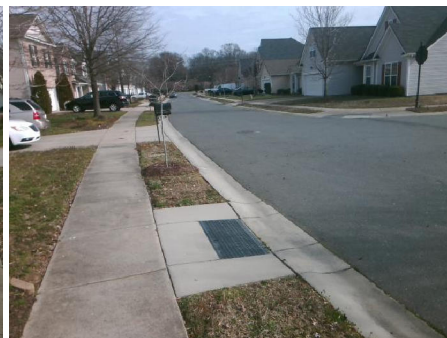
R304.5.1, R304.2.2

Compliance	Description	Data	Compliance	Description	Data
N/A	Ramp Length (in)	48.0	No	Ramp Slope (%)	11.8
No	Ramp Width (in)	47.0	Yes	Ramp XSlope (%)	1.4
N/A	Flare Type LT	N/A	N/A	Flare Type RT	N/A
N/A	Flare Slope LT (%)	N/A	N/A	Flare Slope RT (%)	N/A
N/A	Flare Traversable LT?	N/A	N/A	Flare Traversable RT?	N/A
N/A	Landing Length (in)	N/A	N/A	DWS Provided?	N/A
N/A	Landing Width (in)	N/A	N/A	DWS Contrast?	N/A
N/A	Landing Slope (%)	N/A	N/A	DWS Length (in)	N/A
N/A	Landing X Slope (%)	N/A	N/A	DWS Full Width?	N/A
N/A	Landing Curb? (Y/N)	N/A	N/A	DWS Offset (in)	N/A
N/A	Shared Landing?	N/A			
N/A	Gutter Ponding?	N/A	N/A	Gutter Slope (%)	N/A
N/A	Gutter Lip Ht (in)	N/A	N/A	Gutter X Slope (%)	N/A
N/A	Painted X Walk1?	No	N/A	Painted X Walk2?	N/A
	X Walk 1 Direction	To SE		X Walk 2 Direction	N/A
N/A	X Walk 1 Width (in)	N/A	N/A	X Walk 2 Width (in)	N/A
	X Walk 1 Slope (%)	4.2		X Walk 2 Slope (%)	N/A
	X Walk 1 X Slope (%)	0.3		X Walk 2 X Slope (%)	N/A

N/A	Ramp inside XWalk1?	N/A	N/A	Ramp inside XWalk2?	N/A
	Road Slope (%)	N/A	N/A	Clear Space?	N/A
	Road X Slope (%)	N/A	N/A	Clear Space to XWalk (in)	N/A
N/A	Any Obstructions?	N/A	N/A	Storm Grate/Utility Hazard?	N/A
	Obstruction Type			Storm Grate/Utility Type	
		N/A			N/A
			Yes	Surface Condition? (G/P)	Good

Remove & Replace Entire Ramp.
