Access Compliance Report

Public Rights-of-Way (Curb Ramps)

Intersection ID: 13442	Main Street: MORRIS_FIELD_DR	Cross Street: AIRPORT_CENTER_PY	Location: NE
ADA ID: 783B81861287	Ramp Type: Perp	Initial Pass/Fail: Fail	Overall Compliance: No
Severity Score: 21.25			
Codes/Mitigation Info/Possible Solution		Field Measurements/Component Compliance

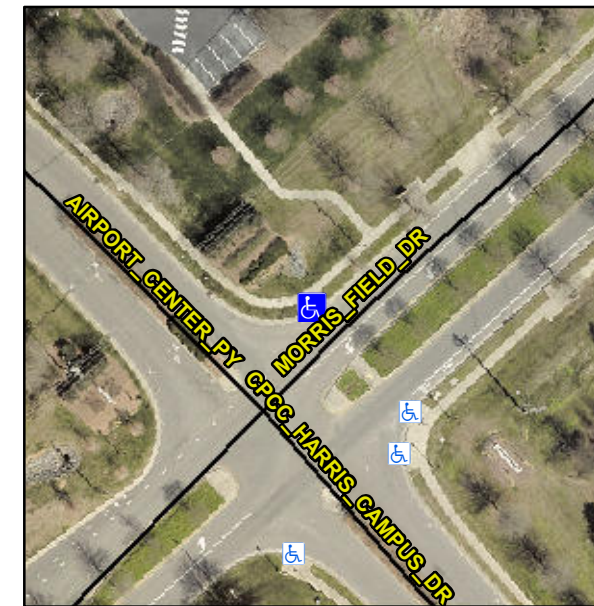
Not Found, R304.5.1, R304.2.2

Compliance	Description	Data	Compliance	Description	Data
N/A	Ramp Length (in)	71.0	No	Ramp Slope (%)	8.8
No	Ramp Width (in)	47.0	Yes	Ramp XSlope (%)	0.3
N/A	Flare Type LT	N/A	N/A	Flare Type RT	N/A
N/A	Flare Slope LT (%)	N/A	N/A	Flare Slope RT (%)	N/A
N/A	Flare Traversable LT?	N/A	N/A	Flare Traversable RT?	N/A
N/A	Landing Length (in)	N/A	N/A	DWS Provided?	N/A
N/A	Landing Width (in)	N/A	N/A	DWS Contrast?	N/A
N/A	Landing Slope (%)	N/A	N/A	DWS Length (in)	N/A
N/A	Landing X Slope (%)	N/A	N/A	DWS Full Width?	N/A
N/A	Landing Curb? (Y/N)	N/A	N/A	DWS Offset (in)	N/A
N/A	Shared Landing?	N/A			
N/A	Gutter Ponding?	N/A	N/A	Gutter Slope (%)	N/A
N/A	Gutter Lip Ht (in)	N/A	N/A	Gutter X Slope (%)	N/A
N/A	Painted X Walk1?	No	N/A	Painted X Walk2?	N/A
	X Walk 1 Direction	To SE		X Walk 2 Direction	N/A
N/A	X Walk 1 Width (in)	N/A	N/A	X Walk 2 Width (in)	N/A
	X Walk 1 Slope (%)	2.7		X Walk 2 Slope (%)	N/A
	X Walk 1 X Slope (%)	2.1		X Walk 2 X Slope (%)	N/A

N/A	Ramp inside XWalk1?	N/A	N/A	Ramp inside XWalk2?	N/A
	Road Slope (%)	N/A	N/A	Clear Space?	N/A
	Road X Slope (%)	N/A	N/A	Clear Space to XWalk (in)	N/A
N/A	Any Obstructions?	N/A	N/A	Storm Grate/Utility Hazard?	N/A
	Obstruction Type			Storm Grate/Utility Type	
		N/A			N/A
			Yes	Surface Condition? (G/P)	Good

Possible Solutions:

Remove & Replace Entire Ramp.
