Access Compliance Report

Public Rights-of-Way

(Curb Ramps)

Intersection ID: 23166	Main Street: LAUREL_POINTE_WY	Cross Street: LAUREL_VIEW_DR	Location: SE
ADA ID: 783CF280086A	Ramp Type: Perp	Initial Pass/Fail: Fail	Overall Compliance: No
Severity Score: 12.5			
Codes/Mitigation Info/Possible Solution		Field Measurements/Component Compliance

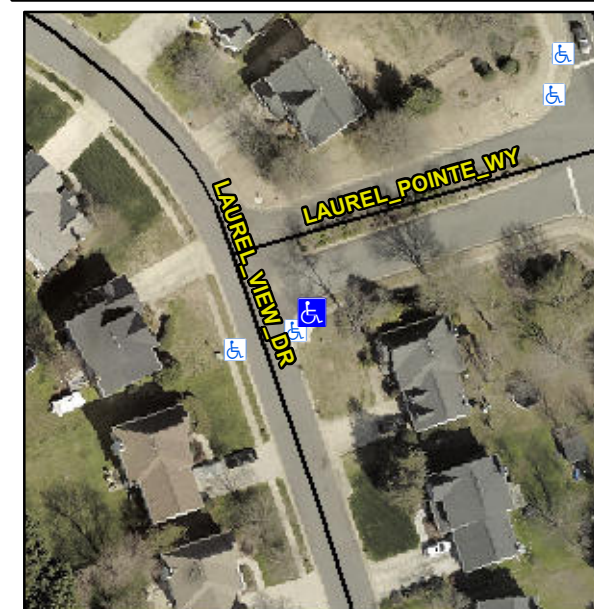
Not Found, R304.2.2

Compliance	Description	Data	Compliance	Description	Data
N/A	Ramp Length (in)	96.0	No	Ramp Slope (%)	10.9
Yes	Ramp Width (in)	48.0	Yes	Ramp XSlope (%)	1.3
N/A	Flare Type LT	N/A	N/A	Flare Type RT	N/A
N/A	Flare Slope LT (%)	N/A	N/A	Flare Slope RT (%)	N/A
N/A	Flare Traversable LT?	N/A	N/A	Flare Traversable RT?	N/A
N/A	Landing Length (in)	N/A	N/A	DWS Provided?	N/A
N/A	Landing Width (in)	N/A	N/A	DWS Contrast?	N/A
N/A	Landing Slope (%)	N/A	N/A	DWS Length (in)	N/A
N/A	Landing X Slope (%)	N/A	N/A	DWS Full Width?	N/A
N/A	Landing Curb? (Y/N)	N/A	N/A	DWS Offset (in)	N/A
N/A	Shared Landing?	N/A			
N/A	Gutter Ponding?	N/A	N/A	Gutter Slope (%)	N/A
N/A	Gutter Lip Ht (in)	N/A	N/A	Gutter X Slope (%)	N/A
N/A	Painted X Walk1?	No	N/A	Painted X Walk2?	N/A
	X Walk 1 Direction	To N		X Walk 2 Direction	N/A
N/A	X Walk 1 Width (in)	N/A	N/A	X Walk 2 Width (in)	N/A
	X Walk 1 Slope (%)	3.2		X Walk 2 Slope (%)	N/A
	X Walk 1 X Slope (%)	1.8		X Walk 2 X Slope (%)	N/A

N/A	Ramp inside XWalk1?	N/A	N/A	Ramp inside XWalk2?	N/A
	Road Slope (%)	N/A	N/A	Clear Space?	N/A
	Road X Slope (%)	N/A	N/A	Clear Space to XWalk (in)	N/A
N/A	Any Obstructions?	N/A	N/A	Storm Grate/Utility Hazard?	N/A
	Obstruction Type			Storm Grate/Utility Type	
		N/A			N/A
			Yes	Surface Condition? (G/P)	Good

Remove & Replace Entire Ramp.
