# Access Compliance Report

## Public Rights-of-Way

| Intersection ID: 14513 | Main Street: N_CHASE_ST | Cross Street: VAIL_AV | Location: NE |
| ADA ID: 784483B00331 | Ramp Type: BlendTrans1 | Initial Pass/Fail: Fail | Overall Compliance: No |

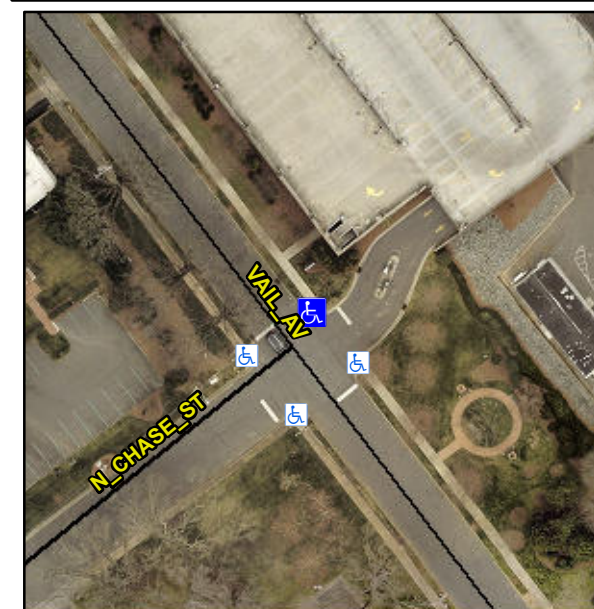
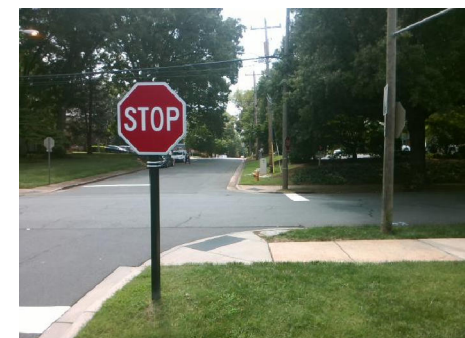
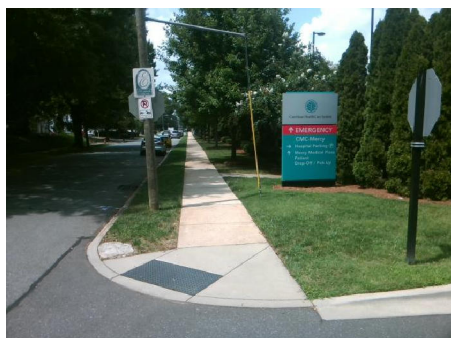
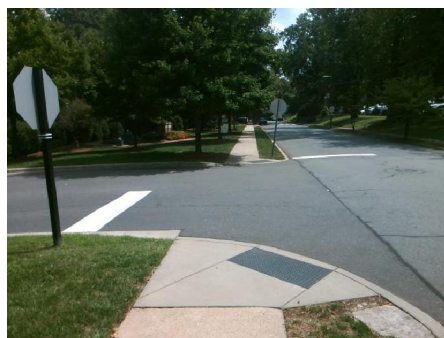
| Severity Score: 1.25 | | | |

**Not Found, R304.5.3**

| Compliance | Description | Data | Compliance | Description | Data |
|---|---|---|---|---|---|
| Yes | Ramp Width (in) | 48.0 | No | BlendTrans XSlope (%) | 3.4 |
| | | | No | Curb Slope (%) | 8.6 |

**Remove & Replace Curb Ramp With Two New Directional Ramps or Equivalent.**

Total Cost: \$ 3200.00
