# Access Compliance Report

## Public Rights-of-Way

### (Curb Ramps)

| Intersection ID: 44077 | Main Street: NEWLANDS_CORNER_LN | Cross Street: FOREST_RUN_LN | Location: NE |

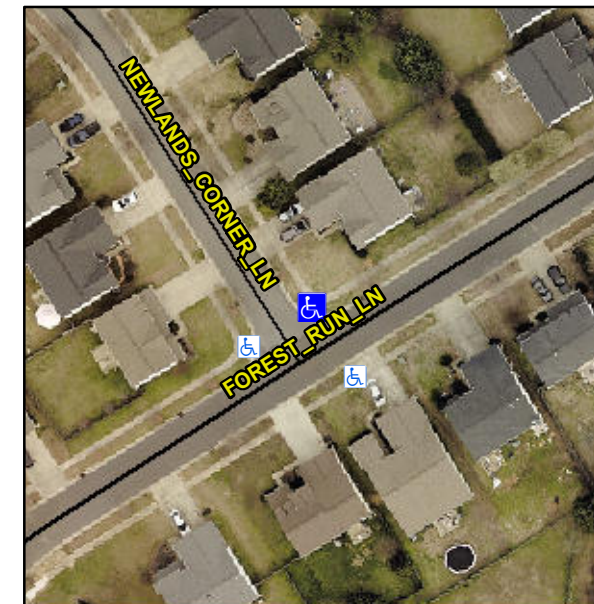
| ADA ID: 785A7CE2BB23 | Ramp Type: PerpDiag | Initial Pass/Fail: Fail | Overall Compliance: No |
| Severity Score: 35 | | | |

| Compliance | Description | Data | Compliance | Description | Data |
|---|---|---|---|---|---|
| No | Ramp Width (in) | 25.0 | Yes | Ramp XSlope (%) | 2.0 |

**Remove & Replace Curb Ramp With Two New Directional Ramps or Equivalent.**

**R304.5.1**

Total Cost: \$ 3200.00

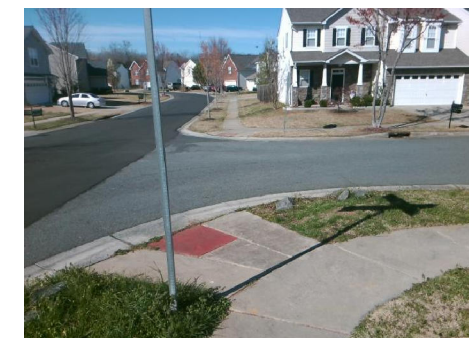
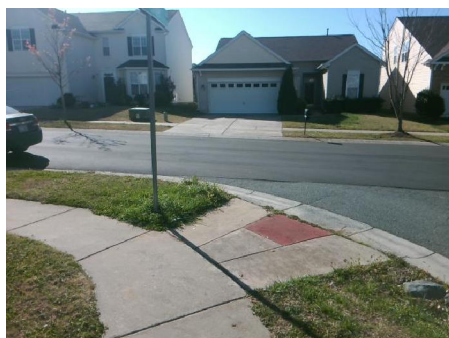
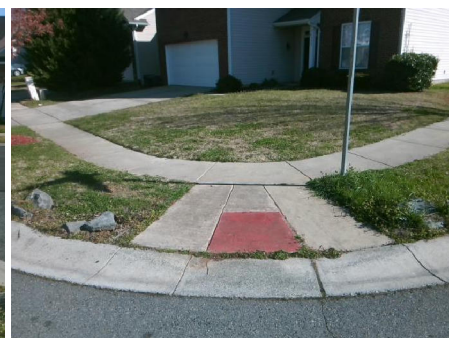
| Compliance | Description | Data | Compliance | Description | Data |
|---|---|---|---|---|---|
| N/A | Ramp Length (in) | 73.0 | Yes | Ramp Slope (%) | 5.0 |
| | | Yes | | Surface Condition? (G/P) | Good |
