Access Compliance Report

Public Rights-of-Way

(Curb Ramps)

Intersection ID: 10025	Main Street: HORNWOOD_CT	Cross Street: ROTHERBY_CT	Location: SW
ADA ID: 78665422881F	Ramp Type: Perp	Initial Pass/Fail: Fail	Overall Compliance: No
Severity Score: 18.75			
Codes/Mitigation Info/Possible Solution		Field Measurements/Component Compliance

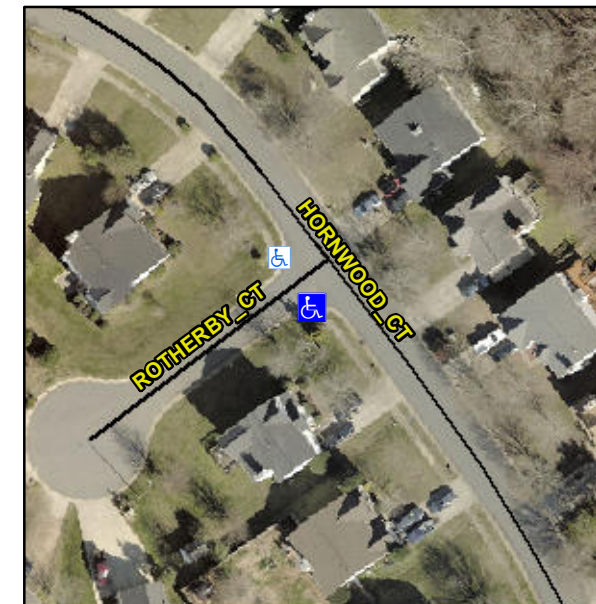
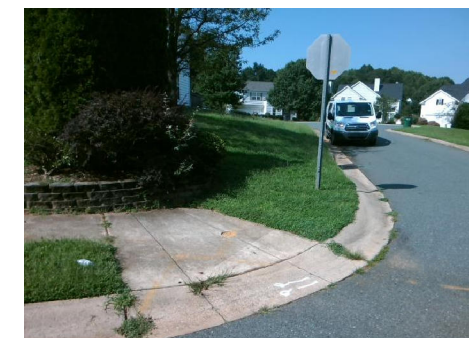
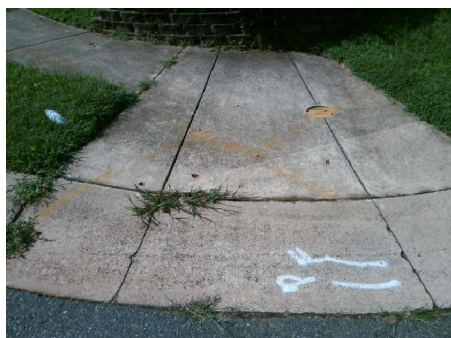
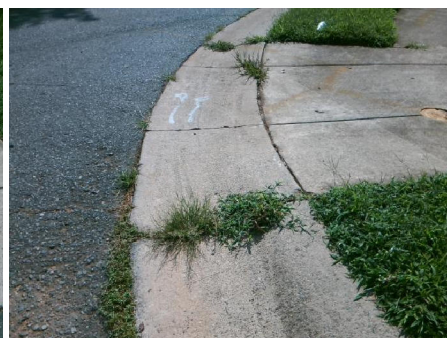
R304.5.1, R304.5.3

Compliance	Description	Data	Compliance	Description	Data
N/A	Ramp Length (in)	46.5	Yes	Ramp Slope (%)	5.6
No	Ramp Width (in)	35.5	No	Ramp XSlope (%)	4.2
N/A	Flare Type LT	N/A	N/A	Flare Type RT	N/A
N/A	Flare Slope LT (%)	N/A	N/A	Flare Slope RT (%)	N/A
N/A	Flare Traversable LT?	N/A	N/A	Flare Traversable RT?	N/A
N/A	Landing Length (in)	N/A	N/A	DWS Provided?	N/A
N/A	Landing Width (in)	N/A	N/A	DWS Contrast?	N/A
N/A	Landing Slope (%)	N/A	N/A	DWS Length (in)	N/A
N/A	Landing X Slope (%)	N/A	N/A	DWS Full Width?	N/A
N/A	Landing Curb? (Y/N)	N/A	N/A	DWS Offset (in)	N/A
N/A	Shared Landing?	N/A			
N/A	Gutter Ponding?	N/A	N/A	Gutter Slope (%)	N/A
N/A	Gutter Lip Ht (in)	N/A	N/A	Gutter X Slope (%)	N/A
N/A	Painted X Walk1?	No	N/A	Painted X Walk2?	N/A
	X Walk 1 Direction	To NW		X Walk 2 Direction	N/A
N/A	X Walk 1 Width (in)	N/A	N/A	X Walk 2 Width (in)	N/A
	X Walk 1 Slope (%)	3.4		X Walk 2 Slope (%)	N/A
	X Walk 1 X Slope (%)	2.2		X Walk 2 X Slope (%)	N/A

N/A	Ramp inside XWalk1?	N/A	N/A	Ramp inside XWalk2?	N/A
	Road Slope (%)	N/A	N/A	Clear Space?	N/A
	Road X Slope (%)	N/A	N/A	Clear Space to XWalk (in)	N/A
N/A	Any Obstructions?	N/A	N/A	Storm Grate/Utility Hazard?	N/A
	Obstruction Type			Storm Grate/Utility Type	
		N/A			N/A
			Yes	Surface Condition? (G/P)	Good

Remove & Replace Entire Ramp.

Total Cost: \$ 1850.00
