Intersection ID: N/A	Main Street: PERIMETER_PY	Cross Street: N/A	Location:	NW
ADA ID: 786C222CD551	Ramp Type: PerpDiag	Initial Pass/Fail: Pass	Overall Compliance: No	Severity Score: 10.25

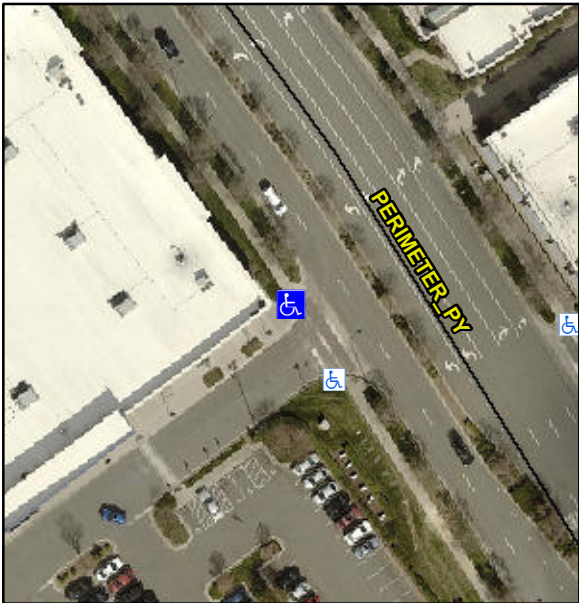
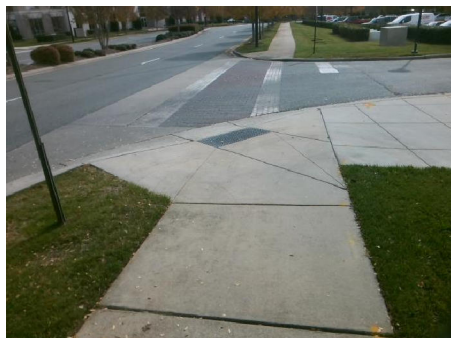
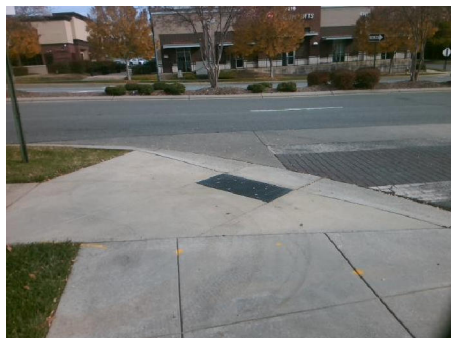
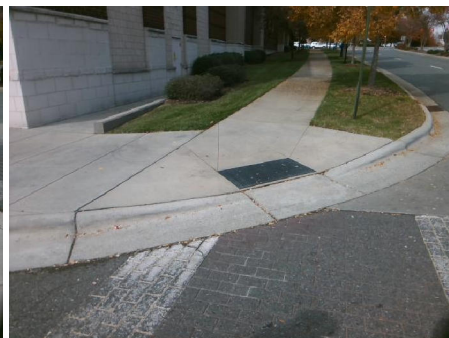
Possible Solutions:		Compliance	Description	Data	Compliance	Description	Data
	Remove & Replace Curb Ramp With Two New Directional Ramps or Equivalent. Remove & Replace Gutter.		N/A	Ramp Length (in)	77.0	Yes	Ramp Slope (%)	7.6
			Yes	Ramp Width (in)	48.0	No	Ramp XSlope (%)	3.2
			N/A	Flare Type LT	Sloped	N/A	Flare Type RT	N/A
			N/A	Flare Slope LT (%)	1.7	N/A	Flare Slope RT (%)	12.5
			N/A	Flare Traversable LT?	Yes	N/A	Flare Traversable RT?	No
			No	Landing Length (in)	N/A	Yes	DWS Provided?	Yes
	Surveyor Notes:		No	Landing Width (in)	N/A	Yes	DWS Contrast?	Yes
	N/A		No	Landing Slope (%)	N/A	Yes	DWS Length (in)	24.5
	PROW/ADA: Not Found, R304.5.3, R304.2.1, R304.2.2-Perp, R304.3.2-Para		No	Landing X Slope (%)	N/A	Yes	DWS Full Width?	Yes
N/A			Landing Curb? (Y/N)	No	Yes	DWS Offset (in)	2.0	
N/A			Shared Landing?	No

Yes			Gutter Ponding?	No	Yes	Gutter Slope (%)	4.3	
Yes			Gutter Lip Ht (in)	0.0	No	Gutter X Slope (%)	2.9	
N/A			Painted X Walk1?	Yes	N/A	Painted X Walk2?	No	
			X Walk 1 Direction	To S		X Walk 2 Direction	To E	
N/A			X Walk 1 Width (in)	71.0	N/A	X Walk 2 Width (in)	N/A	
			X Walk 1 Slope (%)	1.4		X Walk 2 Slope (%)	3.9	
	X Walk 1 X Slope (%)	1.9		X Walk 2 X Slope (%)	2.4			
Yes	Ramp inside XWalk1?	Yes	N/A	Ramp inside XWalk2?	N/A			
	Road Slope (%)	4.4	N/A	Clear Space?	Yes			
	Road X Slope (%)	1.0	N/A	Clear Space to XWalk (in)	N/A			
Yes	Any Obstructions?	No	Yes	Storm Grate/Utility Hazard?	No			
	Obstruction Type			Storm Grate/Utility Type				
Total Cost:		\$	3950.00	N/A		N/A		
					Yes	Surface Condition? (G/P)	Good
