## **Access Compliance Report Public Rights-of-Way** (Curb Ramps)

Intersection ID: 51751 Main Street: GOLF\_LINKS\_DR Cross Street: GOLF LINKS DR N Location: NW ADA ID: 786CDFF279EB Ramp Type: Combination1Diag Initial Pass/Fail: Fail **Overall Compliance: No Severity Score:**

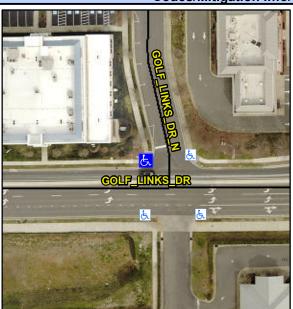
•	
N/A	Ramp Length LT (in)	36.0	N/A	Ramp Length RT (in)	56.0
Yes	Ramp Width LT (in)	48.0	Yes	Ramp Width RT (in)	48.0
Yes	Ramp Slope LT (%)	6.3	Yes	Ramp Slope RT (%)	6.5
Yes	Ramp XSlope LT (%)	0.5	Yes	Ramp XSlope RT (%)	0.7
N/A	Ramp Length (in)	47.0	Yes	Ramp Slope (%)	7.9
No	Ramp Width (in)	43.0	No	Ramp XSlope (%)	5.2
N/A	Flare Type LT	N/A	N/A	Flare Type RT	N/A
N/A	Flare Slope LT (%)	N/A	N/A	Flare Slope RT (%)	N/A
N/A	Flare Traversable LT?	N/A	N/A	Flare Traversable RT?	N/A
N/A	Landing Length (in)	N/A	N/A	DWS Provided?	N/A
N/A	Landing Width (in)	N/A	N/A	DWS Contrast?	N/A
N/A	Landing Slope (%)	N/A	N/A	DWS Length (in)	N/A
N/A	Landing X Slope (%)	N/A	N/A	DWS Full Width?	N/A
N/A	Landing Curb? (Y/N)	N/A	N/A	DWS Offset (in)	N/A
N/A	Shared Landing?	N/A			
N/A	Gutter Ponding?	N/A	N/A	Gutter Slope (%)	N/A
N/A	Gutter Lip Ht (in)	N/A	N/A	Gutter X Slope (%)	N/A
N/A	Painted X Walk1?	No	N/A	Painted X Walk2?	No
	X Walk 1 Direction	To S		X Walk 2 Direction	To E

X Walk 1 Width (in)	N/A		X Walk 2 Width (in)	N/A
	X Walk 1 Slope (%)	0.8		X Walk 2 Slope (%)	5.4
	X Walk 1 X Slope (%)	6.2		X Walk 2 X Slope (%)	2.9
N/A	Ramp inside XWalk1?	N/A	N/A	Ramp inside XWalk2?	N/A
	Road Slope (%)	4.8		Clear Space?	N/A
	Road X Slope (%)	5.5	N/A	Clear Space to XWalk (in)	N/A
1			N/A	Any Obstruction?	N/A
				Obstruction Type	
	En I				N/A

Possible Solutions: Remove & Replace Curb Ramp With Two New Directional Ramps or Equivalent. Surveyor Notes: N/A PROW/ADA: Not Found, R304.5.1, R304.5.3
