# Access Compliance Report

## Public Rights-of-Way

### (Curb Ramps)

| Intersection ID: 11878 | Main Street: MIMOSA_AV | Cross Street: THE_PLAZA | Location: SE |

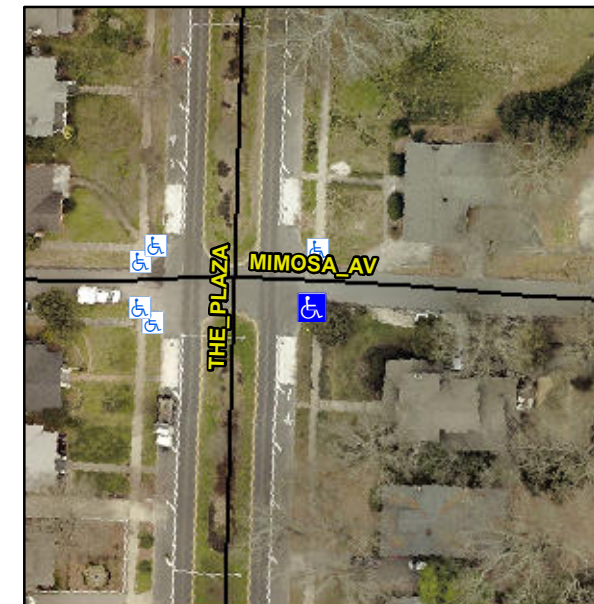
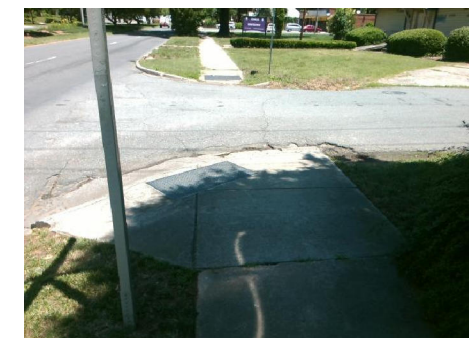
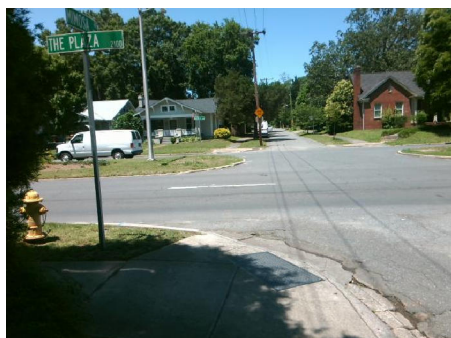
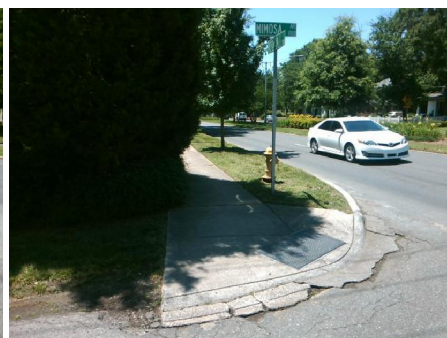
**Not Found, R304.5.3, R305.1.4, R305.2, R302.7, R302.7.2, R304.5.4**

| Compliance | Description | Data | Compliance | Description | Data |
|---|---|---|---|---|---|
| No | Landing X Slope (%) | 3.2 | No | DWS Full Width? | No |
| N/A | Landing Curb? (Y/N) | No | No | DWS Offset (in) | 7.0 |
| No | Gutter Ponding? | Yes | No | Gutter Slope (%) | 5.6 |
| No | Gutter Lip Ht (in) | 3.0 | Yes | Gutter X Slope (%) | 1.7 |

**Remove & Replace Curb Ramp With Two New Directional Ramps or Equivalent. Remove & Replace Gutter.**
