Intersection ID: 15459		Main Street: CONISTON_PL		Cross Street: S_KINGS_DR		Location:		SE			
ADA ID: 78760AF89D08		Ramp Type: Directional1		Initial Pass/Fail: Fail		Overall Compliance: No		Severity Score: 1.25			
Codes/Mitigation Info/Possible Solution				Field Measurements/Component Compliance

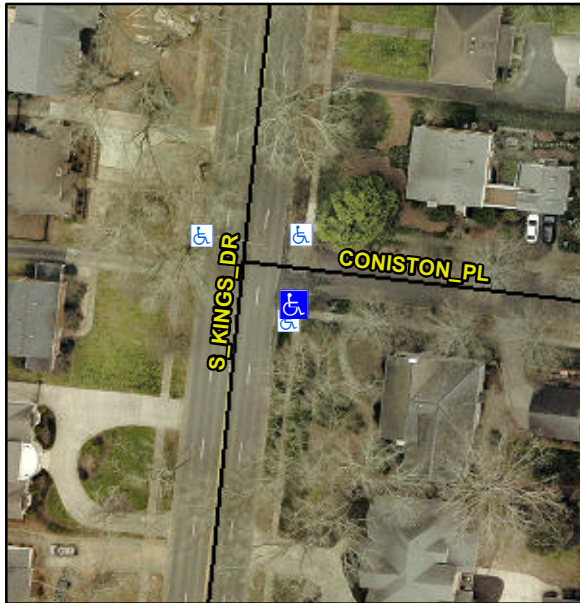
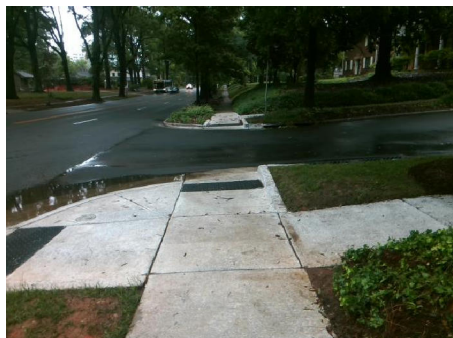
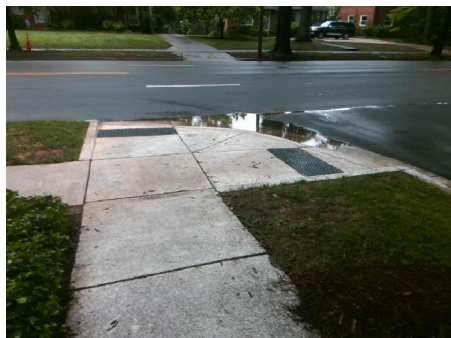
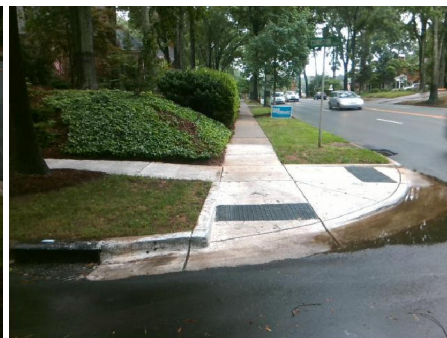
Possible Solutions:		Compliance		Description		Data	
				Remove & Replace Entire Ramp.		N/A		Ramp Length (in)		73.0	
Surveyor Notes:				N/A		Yes		Ramp Width (in)		51.0	
						Yes		Ramp Slope (%)		5.2	
PROW/ADA:				R304.5.3		No		Ramp XSlope (%)		2.3	
						N/A		Flare Type LT		N/A	
						N/A		Flare Slope LT (%)		N/A	
						N/A		Flare Traversable LT?		N/A	
						N/A		Landing Length (in)		0.0	
						N/A		Landing Width (in)		0.0	
						N/A		Landing Slope (%)		0.0	
						N/A		Landing X Slope (%)		0.0	
						N/A		Landing Curb? (Y/N)		N/A	
						N/A		Shared Landing?		N/A	
						N/A		Gutter Ponding?		0.0	
						N/A		Gutter Lip Ht (in)		0.0

N/A		Painted X Walk1?		No	
								X Walk 1 Direction		To NW	
						N/A		X Walk 1 Width (in)		N/A	
						N/A		X Walk 1 Slope (%)		2.0	
						N/A		X Walk 1 X Slope (%)		2.0	
						N/A		Ramp inside XWalk1?		N/A	
						N/A		Any Obstructions?		N/A	
								Obstruction Type		Yes	
						N/A		Surface Condition? (G/P)		Good	
						N/A		Curb Slope (%)		5.7
