# Access Compliance Report

## Public Rights-of-Way

### (Curb Ramps)

Intersection ID: 12517	Main Street: N_SHARON_AMITY_RD	Cross Street: SHAMROCK_DR	Location: NW
ADA ID: 789847903AB3	Ramp Type: Perp	Initial Pass/Fail: Fail	Overall Compliance: No
Severity Score: 13.75			
Codes/Mitigation Info/Possible Solution		Field Measurements/Component Compliance

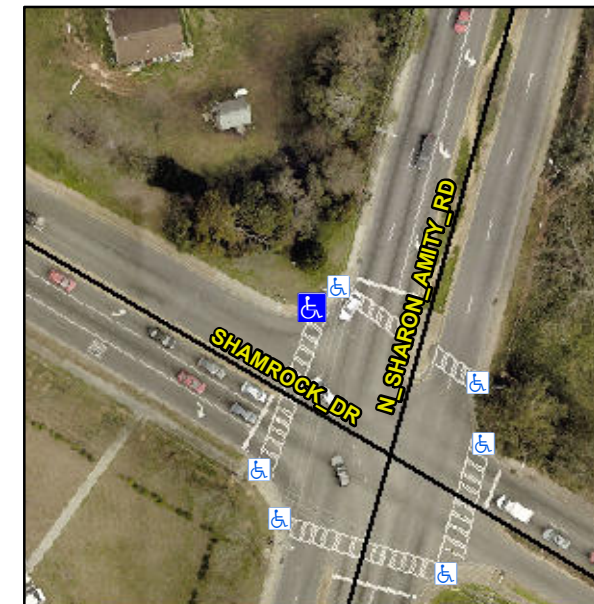
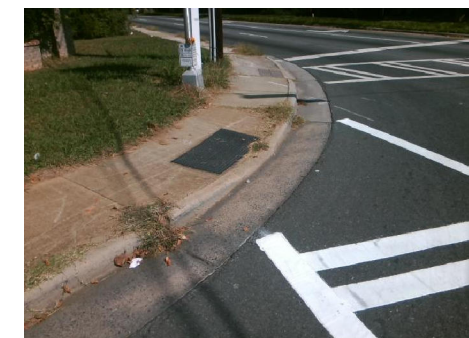
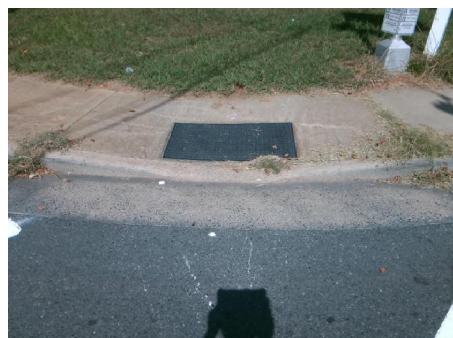
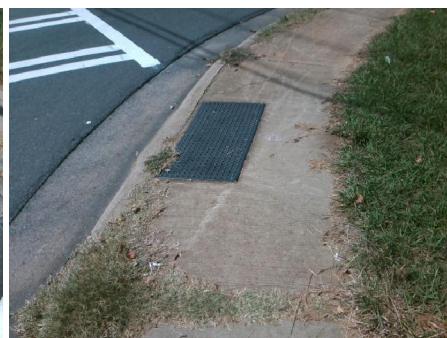
**Not Found, R304.2.2, R304.5.3**

Compliance	Description	Data	Compliance	Description	Data
N/A	Ramp Length (in)	58.5	No	Ramp Slope (%)	9.8
Yes	Ramp Width (in)	48.0	No	Ramp XSlope (%)	5.0
N/A	Flare Type LT	N/A	N/A	Flare Type RT	N/A
N/A	Flare Slope LT (%)	N/A	N/A	Flare Slope RT (%)	N/A
N/A	Flare Traversable LT?	N/A	N/A	Flare Traversable RT?	N/A
N/A	Landing Length (in)	N/A	N/A	DWS Provided?	N/A
N/A	Landing Width (in)	N/A	N/A	DWS Contrast?	N/A
N/A	Landing Slope (%)	N/A	N/A	DWS Length (in)	N/A
N/A	Landing X Slope (%)	N/A	N/A	DWS Full Width?	N/A
N/A	Landing Curb? (Y/N)	N/A	N/A	DWS Offset (in)	N/A
N/A	Shared Landing?	N/A			
N/A	Gutter Ponding?	N/A	N/A	Gutter Slope (%)	N/A
N/A	Gutter Lip Ht (in)	N/A	N/A	Gutter X Slope (%)	N/A
N/A	Painted X Walk1?	Yes	N/A	Painted X Walk2?	N/A
	X Walk 1 Direction	To SW		X Walk 2 Direction	N/A
N/A	X Walk 1 Width (in)	92.0	N/A	X Walk 2 Width (in)	N/A
	X Walk 1 Slope (%)	0.2		X Walk 2 Slope (%)	N/A
	X Walk 1 X Slope (%)	1.5		X Walk 2 X Slope (%)	N/A

N/A	Ramp inside XWalk1?	Yes	N/A	Ramp inside XWalk2?	N/A
	Road Slope (%)	N/A	N/A	Clear Space?	N/A
	Road X Slope (%)	N/A	N/A	Clear Space to XWalk (in)	N/A
N/A	Any Obstructions?	N/A	N/A	Storm Grate/Utility Hazard?	N/A
	Obstruction Type			Storm Grate/Utility Type	
		N/A			N/A
		Yes		Surface Condition? (G/P)	Good

**Remove & Replace Entire Ramp.**
