Access Compliance Report

Public Rights-of-Way

(Curb Ramps)

Intersection ID: 51776	Main Street: MCVAY_ST	Cross Street: ORANGE_ST	Location:	E
ADA ID: 78A35A4071E9	Ramp Type: Directional1	Initial Pass/Fail: Pass	Overall Compliance: No	Severity Score: 2.75
Codes/Mitigation Info/Possible Solution		Field Measurements/Component Compliance

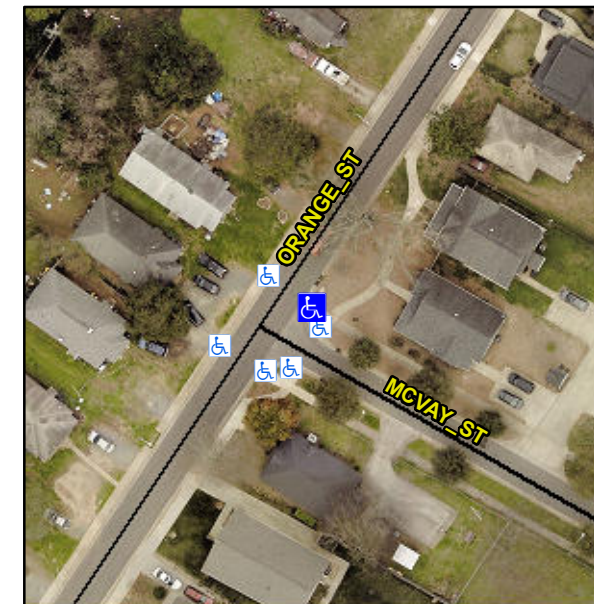
Compliance	Description	Data	Compliance	Description	Data
N/A	Ramp Length (in)	93.0	No	Grade Break?	No
Yes	Ramp Width (in)	60.0	N/A	Grade Break Slope (%)	7.0
Yes	Ramp Slope (%)	7.7	N/A	Grade Break XSlope (%)	5.6
No	Ramp XSlope (%)	3.3			
N/A	Flare Type LT	N/A	N/A	Flare Type RT	N/A
N/A	Flare Slope LT (%)	N/A	N/A	Flare Slope RT (%)	N/A
N/A	Flare Traversable LT?	N/A	N/A	Flare Traversable RT?	N/A
Yes	Landing Length (in)	60.0	Yes	DWS Provided?	Yes
Yes	Landing Width (in)	60.0	Yes	DWS Contrast?	Yes
Yes	Landing Slope (%)	1.3	Yes	DWS Length (in)	24.0
Yes	Landing X Slope (%)	0.9	No	DWS Full Width?	No
N/A	Landing Curb? (Y/N)	N/A	Yes	DWS Offset LT (in)	28.0
N/A	Shared Landing?	Yes	No	DWS Offset RT (in)	3.0
Yes	Gutter Ponding?	No	Yes	Gutter Slope (%)	2.8
Yes	Gutter Lip Ht (in)	0.0	Yes	Gutter X Slope (%)	1.6
N/A	Painted X Walk1?	No		Road Slope (%)	2.2
	X Walk 1 Direction	To W		Road X Slope (%)	1.3
	X Walk 1 Width (in)	N/A		Clear Space?	Yes

X Walk 1 Slope (%)	2.2	N/A	Clear Space to XWalk (in)	N/A
	X Walk 1 X Slope (%)	1.3	Yes	Storm Grate/Utility Hazard?	No
N/A	Ramp inside XWalk1?	N/A		Storm Grate/Utility Type	
Yes	Any Obstructions?	No			N/A
	Obstruction Type		Yes	Surface Condition? (G/P)	Good
			N/A	Curb Slope (%)	22.1

Possible Solutions:

Remove & Replace Entire Ramp.
