# Access Compliance Report

## Public Rights-of-Way

### (Curb Ramps)

Intersection ID: 10894	Main Street: MILTON_RD	Cross Street: OAK_FOREST_DR	Location: SW
ADA ID: 78A4D7342F09	Ramp Type: PerpDiag	Initial Pass/Fail: Fail	Overall Compliance: No
		Severity Score: 8.75

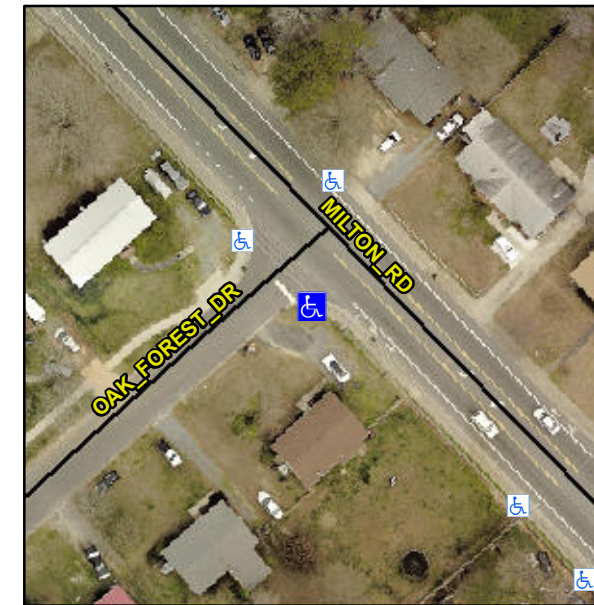
**Not Found, R304.5.1**

Compliance	Description	Data	Compliance	Description	Data
N/A	Ramp Length (in)	59.5	Yes	Ramp Slope (%)	6.8
No	Ramp Width (in)	42.5	Yes	Ramp XSlope (%)	1.7
N/A	Flare Type LT	N/A	N/A	Flare Type RT	N/A
N/A	Flare Slope LT (%)	N/A	N/A	Flare Slope RT (%)	N/A
N/A	Flare Traversable LT?	N/A	N/A	Flare Traversable RT?	N/A
N/A	Landing Length (in)	N/A	N/A	DWS Provided?	N/A
N/A	Landing Width (in)	N/A	N/A	DWS Contrast?	N/A
N/A	Landing Slope (%)	N/A	N/A	DWS Length (in)	N/A
N/A	Landing X Slope (%)	N/A	N/A	DWS Full Width?	N/A
N/A	Landing Curb? (Y/N)	N/A	N/A	DWS Offset (in)	N/A
N/A	Shared Landing?	N/A			
N/A	Gutter Ponding?	N/A	N/A	Gutter Slope (%)	N/A
N/A	Gutter Lip Ht (in)	N/A	N/A	Gutter X Slope (%)	N/A
N/A	Painted X Walk1?	No	N/A	Painted X Walk2?	No
	X Walk 1 Direction	To E		X Walk 2 Direction	To NW
N/A	X Walk 1 Width (in)	N/A	N/A	X Walk 2 Width (in)	N/A
	X Walk 1 Slope (%)	1.8		X Walk 2 Slope (%)	0.5
	X Walk 1 X Slope (%)	1.8		X Walk 2 X Slope (%)	2.0

N/A	Ramp inside XWalk1?	N/A	N/A	Ramp inside XWalk2?	N/A
	Road Slope (%)	3.0	N/A	Clear Space?	N/A
	Road X Slope (%)	1.9	N/A	Clear Space to XWalk (in)	N/A
N/A	Any Obstructions?	N/A	N/A	Storm Grate/Utility Hazard?	N/A
	Obstruction Type			Storm Grate/Utility Type	
		N/A			N/A
			Yes	Surface Condition? (G/P)	Good

**Remove & Replace Curb Ramp With Two New Directional Ramps or Equivalent.**

Total Cost: \$ 3200.00
