Access Compliance Report

Public Rights-of-Way

(Curb Ramps)

Intersection ID: 9578	Main Street: WOODWARD_AV	Cross Street: STATESVILLE_AV	Location: SE
ADA ID: 78C29510D64B	Ramp Type: Combination1	Initial Pass/Fail: Fail	Overall Compliance: No
			Severity Score: 33.75

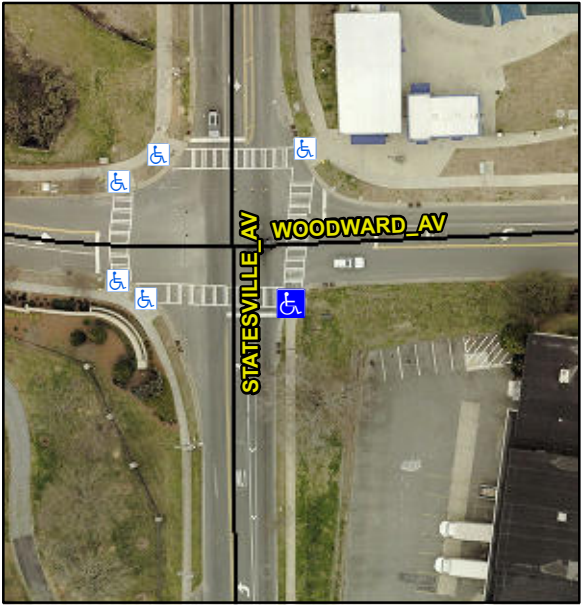
Possible Solutions:		Compliance	Description	Data
	Remove & Replace Entire Ramp.		N/A	Ramp Length LT (in)	38.0
			No	Ramp Width LT (in)	47.0
			Yes	Ramp Slope LT (%)	1.0
			Yes	Ramp XSlope LT (%)	1.1
			N/A	Ramp Length (in)	26.0
			No	Ramp Width (in)	47.5
			N/A	Flare Type LT	N/A
			N/A	Flare Slope LT (%)	N/A
			N/A	Flare Traversable LT?	N/A
<p>Surveyor Notes:</p> <p>LT RP < 5%</p> <p>PROW/ADA:</p> <p>R304.5.1, R304.5.1, R304.5.3, R304.3.2</p>			N/A	Ramp Length RT (in)	55.0
			Yes	Ramp Width RT (in)	48.0
			No	Ramp Slope RT (%)	9.7
			No	Ramp XSlope RT (%)	3.3
			Yes	Ramp Slope (%)	6.6
			No	Ramp XSlope (%)	6.4
			N/A	Flare Type RT	N/A
			N/A	Flare Slope RT (%)	N/A
			N/A	Flare Traversable RT?	N/A
			N/A	DWS Provided?	N/A
<p>Total Cost:</p> <p>\$ 1800.00</p>			N/A	DWS Contrast?	N/A
			N/A	DWS Length (in)	N/A
			N/A	DWS Full Width?	N/A
