## Access Compliance Report Public Rights-of-Way (Curb Ramps)

Intersection ID: 10253Main Street:KILDARE\_DRCross Street:RUTH\_DRLocation:NWADA ID: 78C759C175F0Ramp Type:PerpDiagInitial Pass/Fail:FailOverall Compliance:NoSeverity Score:12.5

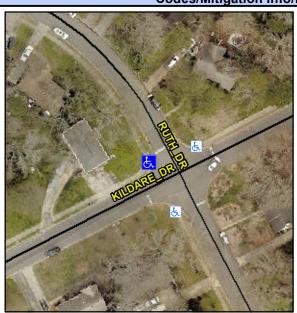
D 1 (1 (1 )		T	D 01 (0/)	
N/A	Ramp Length (in)	53.0	No	Ramp Slope (%)	9.6
Yes	Ramp Width (in)	56.0	Yes	Ramp XSlope (%)	1.6
N/A	Flare Type LT	N/A	N/A	Flare Type RT	N/A
N/A	Flare Slope LT (%)	N/A	N/A	Flare Slope RT (%)	N/A
N/A	Flare Traversable LT?	N/A	N/A	Flare Traversable RT?	N/A
N/A	Landing Length (in)	N/A	N/A	DWS Provided?	N/A
N/A	Landing Width (in)	N/A	N/A	DWS Contrast?	N/A
N/A	Landing Slope (%)	N/A	N/A	DWS Length (in)	N/A
N/A	Landing X Slope (%)	N/A	N/A	DWS Full Width?	N/A
N/A	Landing Curb? (Y/N)	N/A	N/A	DWS Offset (in)	N/A
N/A	Shared Landing?	N/A			
N/A	Gutter Ponding?	N/A	N/A	Gutter Slope (%)	N/A
N/A	Gutter Lip Ht (in)	N/A	N/A	Gutter X Slope (%)	N/A
N/A	Painted X Walk1?	No	N/A	Painted X Walk2?	No
	X Walk 1 Direction	To S		X Walk 2 Direction	To E
N/A	X Walk 1 Width (in)	N/A	N/A	X Walk 2 Width (in)	N/A
	X Walk 1 Slope (%)	1.9		X Walk 2 Slope (%)	1.6
	X Walk 1 X Slope (%)	1.4		X Walk 2 X Slope (%)	0.2
N/A	Ramp inside XWalk1?	N/A	N/A	Ramp inside XWalk2?	N/A

Road Slope (%)	0.9	N/A	Clear Space?	N/A
	Road X Slope (%)	4.9	N/A	Clear Space to XWalk (in)	N/A
N/A	Any Obstructions?	N/A	N/A	Storm Grate/Utility Hazard?	N/A
	Obstruction Type			Storm Grate/Utility Type	
		N/A			N/A

Remove & Replace Curb Ramp With Two New Directional Ramps or Equivalent.
