Access Compliance Report

Public Rights-of-Way

(Curb Ramps)

Intersection ID: N/A	Main Street: SHASTA_LN	Cross Street: SHASTA HILL_CT	Location: E
ADA ID: 78CA551B92DB	Ramp Type: Directional1	Initial Pass/Fail: Fail	Overall Compliance: No
Codes/Mitigation Info/Possible Solution		Field Measurements/Component Compliance

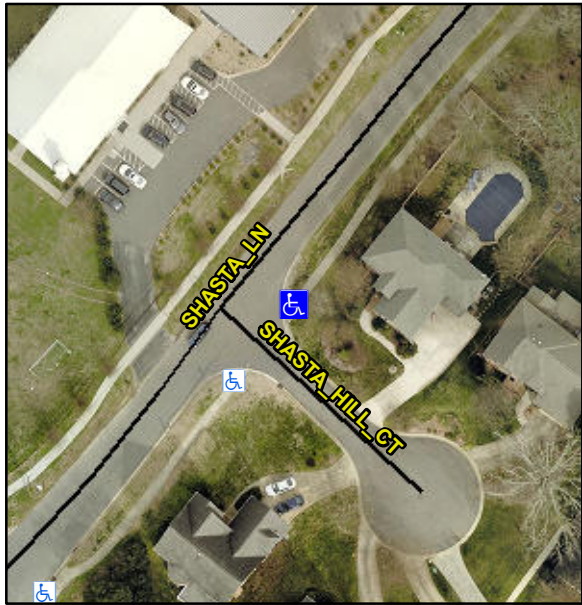
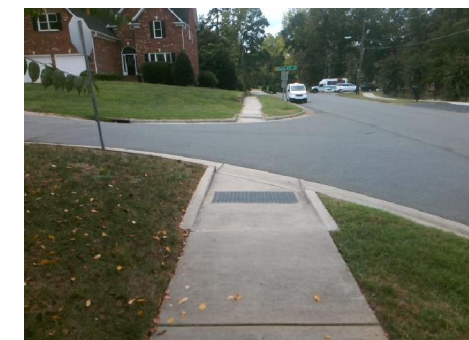
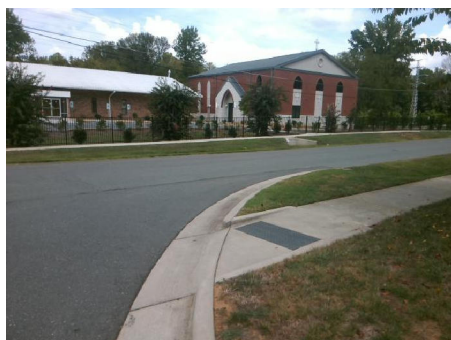
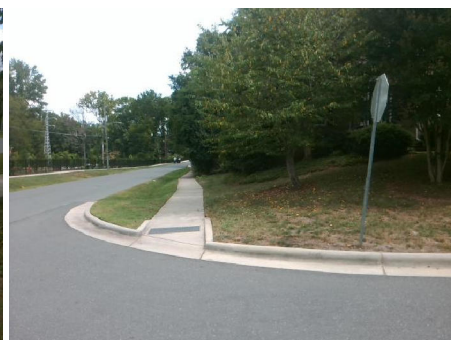
Compliance	Description	Data	Compliance	Description	Data
N/A	Ramp Length (in)	66.5	N/A	Grade Break?	N/A
Yes	Ramp Width (in)	58.0	N/A	Grade Break Slope (%)	0.0
Yes	Ramp Slope (%)	3.8	N/A	Grade Break XSlope (%)	0.0
No	Ramp XSlope (%)	3.0			
N/A	Flare Type LT	N/A	N/A	Flare Type RT	N/A
N/A	Flare Slope LT (%)	N/A	N/A	Flare Slope RT (%)	0.0
N/A	Flare Traversable LT?	N/A	N/A	Flare Traversable RT?	N/A
N/A	Landing Length (in)	0.0	N/A	DWS Provided?	N/A
N/A	Landing Width (in)	0.0	N/A	DWS Contrast?	N/A
N/A	Landing Slope (%)	0.0	N/A	DWS Length (in)	N/A
N/A	Landing X Slope (%)	0.0	N/A	DWS Full Width?	N/A
N/A	Landing Curb? (Y/N)	N/A	N/A	DWS Offset LT (in)	N/A
N/A	Shared Landing?	N/A	N/A	DWS Offset RT (in)	N/A
N/A	Gutter Ponding?	0.0	N/A	Gutter Slope (%)	N/A
N/A	Gutter Lip Ht (in)	0.0	N/A	Gutter X Slope (%)	N/A
N/A	Painted X Walk1?	No		Road Slope (%)	0.3
	X Walk 1 Direction	To SW		Road X Slope (%)	2.3
	X Walk 1 Width (in)	N/A		Clear Space?	N/A

X Walk 1 Slope (%)	0.3	N/A	Clear Space to XWalk (in)	N/A
	X Walk 1 X Slope (%)	2.3	N/A	Storm Grate/Utility Hazard?	N/A
N/A	Ramp inside XWalk1?	N/A		Storm Grate/Utility Type	
N/A	Any Obstructions?	N/A			N/A
	Obstruction Type		Yes	Surface Condition? (G/P)	Good
		N/A	N/A	Curb Slope (%)	19.5

Possible Solutions:

Remove & Replace Entire Ramp.

R304.5.3
