Access Compliance Report

Public Rights-of-Way

(Curb Ramps)

Intersection ID: 42726	Main Street: CAMPION_CT	Cross Street: PICKEREL_LN	Location: W
ADA ID: 78DADBA63DC5	Ramp Type: PerpDiag	Initial Pass/Fail: Fail	Overall Compliance: No
		Severity Score: 10

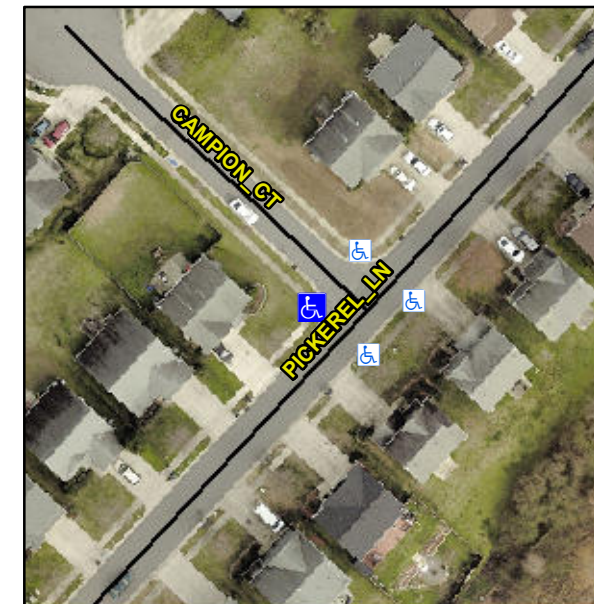
Not Found, R304.5.1, R304.5.3

Compliance	Description	Data	Compliance	Description	Data
N/A	Ramp Length (in)	48.0	Yes	Ramp Slope (%)	5.8
No	Ramp Width (in)	37.0	No	Ramp XSlope (%)	4.6
N/A	Flare Type LT	N/A	N/A	Flare Type RT	N/A
N/A	Flare Slope LT (%)	N/A	N/A	Flare Slope RT (%)	N/A
N/A	Flare Traversable LT?	N/A	N/A	Flare Traversable RT?	N/A
N/A	Landing Length (in)	N/A	N/A	DWS Provided?	N/A
N/A	Landing Width (in)	N/A	N/A	DWS Contrast?	N/A
N/A	Landing Slope (%)	N/A	N/A	DWS Length (in)	N/A
N/A	Landing X Slope (%)	N/A	N/A	DWS Full Width?	N/A
N/A	Landing Curb? (Y/N)	N/A	N/A	DWS Offset (in)	N/A
N/A	Shared Landing?	N/A			
N/A	Gutter Ponding?	N/A	N/A	Gutter Slope (%)	N/A
N/A	Gutter Lip Ht (in)	N/A	N/A	Gutter X Slope (%)	N/A
N/A	Painted X Walk1?	No	N/A	Painted X Walk2?	No
	X Walk 1 Direction	To SE		X Walk 2 Direction	To NE
N/A	X Walk 1 Width (in)	N/A	N/A	X Walk 2 Width (in)	N/A
	X Walk 1 Slope (%)	6.8		X Walk 2 Slope (%)	5.8
	X Walk 1 X Slope (%)	0.6		X Walk 2 X Slope (%)	6.2

N/A	Ramp inside XWalk1?	N/A	N/A	Ramp inside XWalk2?	N/A
	Road Slope (%)	2.8	N/A	Clear Space?	N/A
	Road X Slope (%)	5.2	N/A	Clear Space to XWalk (in)	N/A
N/A	Any Obstructions?	N/A	N/A	Storm Grate/Utility Hazard?	N/A
	Obstruction Type			Storm Grate/Utility Type	
		N/A			N/A
			Yes	Surface Condition? (G/P)	Good

Remove & Replace Curb Ramp With Two New Directional Ramps or Equivalent.
