Access Compliance Report

Public Rights-of-Way

(Curb Ramps)

Intersection ID: 15816	Main Street: BARAWAY_DR	Cross Street: E W T HARRIS BV	Location: SW
ADA ID: 78ECDBCBEA5F	Ramp Type: Perp	Initial Pass/Fail: Fail	Overall Compliance: No
Severity Score: 13.75			
Codes/Mitigation Info/Possible Solution		Field Measurements/Component Compliance

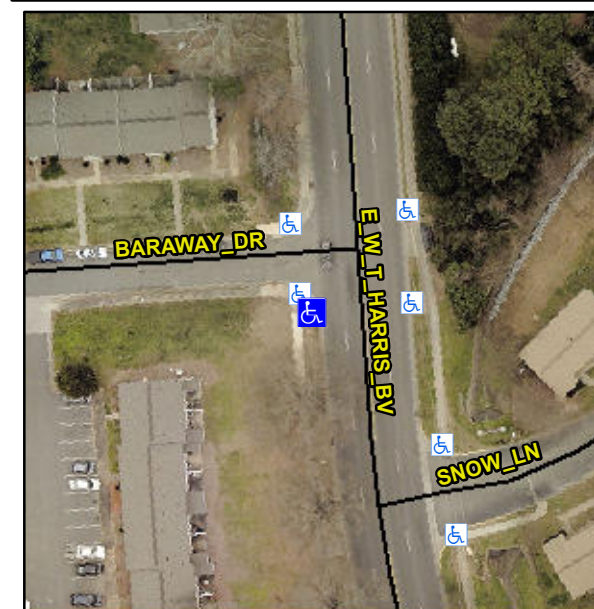
PROW/ADA:

Not Found, R304.2.2, R304.5.3

Compliance	Description	Data	Compliance	Description	Data
N/A	Ramp Length (in)	64.0	No	Ramp Slope (%)	8.7
Yes	Ramp Width (in)	48.0	No	Ramp XSlope (%)	3.0
N/A	Flare Type LT	N/A	N/A	Flare Type RT	N/A
N/A	Flare Slope LT (%)	N/A	N/A	Flare Slope RT (%)	N/A
N/A	Flare Traversable LT?	N/A	N/A	Flare Traversable RT?	N/A
N/A	Landing Length (in)	N/A	N/A	DWS Provided?	N/A
N/A	Landing Width (in)	N/A	N/A	DWS Contrast?	N/A
N/A	Landing Slope (%)	N/A	N/A	DWS Length (in)	N/A
N/A	Landing X Slope (%)	N/A	N/A	DWS Full Width?	N/A
N/A	Landing Curb? (Y/N)	N/A	N/A	DWS Offset (in)	N/A
N/A	Shared Landing?	N/A			
N/A	Gutter Ponding?	N/A	N/A	Gutter Slope (%)	N/A
N/A	Gutter Lip Ht (in)	N/A	N/A	Gutter X Slope (%)	N/A
N/A	Painted X Walk1?	No	N/A	Painted X Walk2?	N/A
	X Walk 1 Direction	To E		X Walk 2 Direction	N/A
N/A	X Walk 1 Width (in)	N/A	N/A	X Walk 2 Width (in)	N/A
	X Walk 1 Slope (%)	1.2		X Walk 2 Slope (%)	N/A
	X Walk 1 X Slope (%)	2.0		X Walk 2 X Slope (%)	N/A

N/A	Ramp inside XWalk1?	N/A	N/A	Ramp inside XWalk2?	N/A
	Road Slope (%)	N/A	N/A	Clear Space?	N/A
	Road X Slope (%)	N/A	N/A	Clear Space to XWalk (in)	N/A
N/A	Any Obstructions?	N/A	N/A	Storm Grate/Utility Hazard?	N/A
	Obstruction Type			Storm Grate/Utility Type	
		N/A			N/A
		Yes		Surface Condition? (G/P)	Good

Possible Solutions:

Remove & Replace Entire Ramp.
