# Access Compliance Report

## Public Rights-of-Way

### (Curb Ramps)

| Intersection ID: 15205 | Main Street: CHEROKEE_RD | Cross Street: FENTON_PL | Location: E |

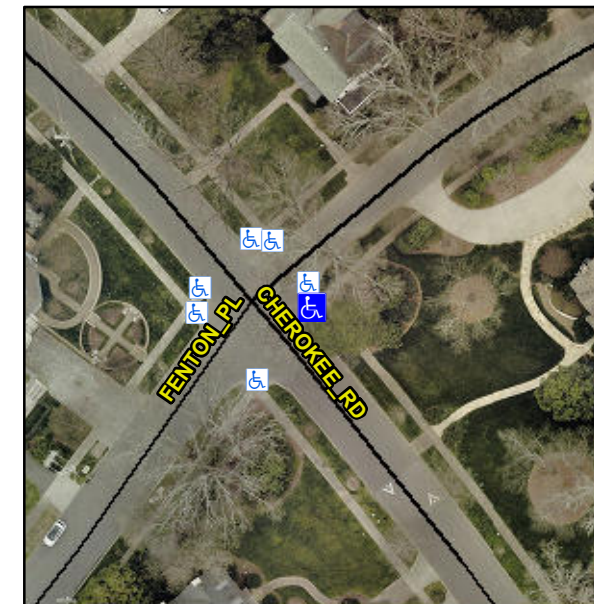
| ADA ID: 78EE149E94AB | Ramp Type: Directional1 | Initial Pass/Fail: Pass | Overall Compliance: No |
| | | Severity Score: 2.75 | |

**R304.2.2-Perp, R304.3.2-Para,  
R304.5.2, R305.1.4**

| Compliance | Description | Data | Compliance | Description | Data |
|---|---|---|---|---|---|
| No | Landing Slope (%) | 2.2 | Yes | DWS Length (in) | 24.0 |
| Yes | Landing X Slope (%) | 0.3 | No | DWS Full Width? | No |

**Remove & Replace Entire Ramp.**
