# Access Compliance Report

## Public Rights-of-Way

| Intersection ID: 16387 | Main Street: BILLINGSLEY_RD | Cross Street: CONSERVANCY_LN | Location: NE |
| ADA ID: 78F812D8BD95 | Ramp Type: PerpDiag | Initial Pass/Fail: Fail | Overall Compliance: No |

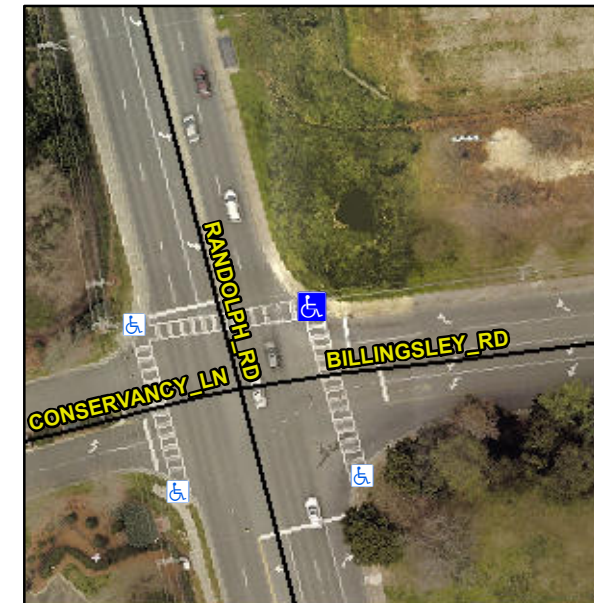
| | | Severity Score: 22.5 | |

| Compliance | Description | Data | Compliance | Description | Data |
|---|---|---|---|---|---|
| N/A | Ramp Length (in) | 72.0 | No | Ramp Slope (%) | 10.6 |
| No | Ramp Width (in) | 43.0 | No | Ramp XSlope (%) | 4.7 |

**Remove & Replace Curb Ramp With Two New Directional Ramps or Equivalent.**

**R304.5.1, R304.2.2, R304.5.3**

Total Cost: \$ 3200.00
