# Access Compliance Report

## Public Rights-of-Way

### (Curb Ramps)

Intersection ID: 3559	Main Street: PERIMETER_PY	Cross Street: W_W_T_HARRIS_BV	Location: NW
ADA ID: 78F97DBB6597	Ramp Type: Perp	Initial Pass/Fail: Fail	Overall Compliance: No
Severity Score: 33.75			
Codes/Mitigation Info/Possible Solution		Field Measurements/Component Compliance

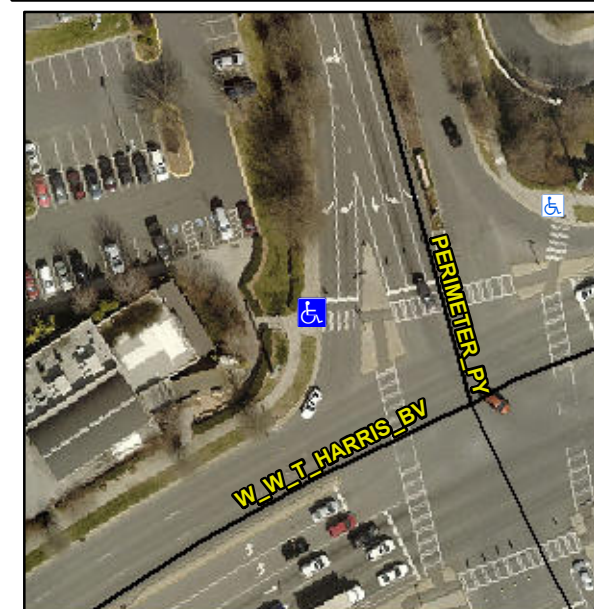
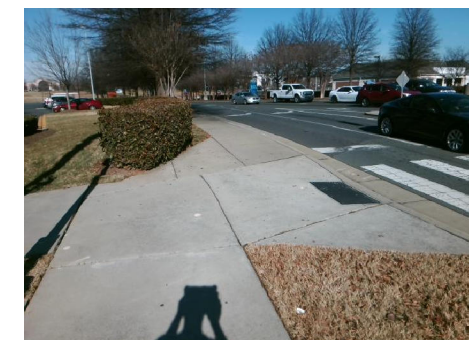
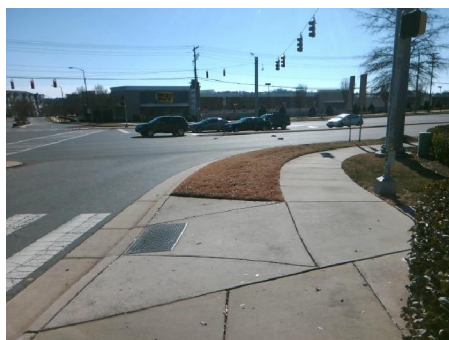
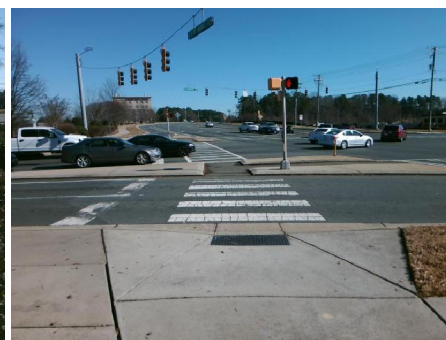
**Not Found, R304.5.1, R304.2.2, R304.5.3**

Compliance	Description	Data	Compliance	Description	Data
N/A	Ramp Length (in)	95.0	No	Ramp Slope (%)	8.8
No	Ramp Width (in)	46.0	No	Ramp XSlope (%)	5.2
N/A	Flare Type LT	N/A	N/A	Flare Type RT	N/A
N/A	Flare Slope LT (%)	N/A	N/A	Flare Slope RT (%)	N/A
N/A	Flare Traversable LT?	N/A	N/A	Flare Traversable RT?	N/A
N/A	Landing Length (in)	N/A	N/A	DWS Provided?	N/A
N/A	Landing Width (in)	N/A	N/A	DWS Contrast?	N/A
N/A	Landing Slope (%)	N/A	N/A	DWS Length (in)	N/A
N/A	Landing X Slope (%)	N/A	N/A	DWS Full Width?	N/A
N/A	Landing Curb? (Y/N)	N/A	N/A	DWS Offset (in)	N/A
N/A	Shared Landing?	N/A			
N/A	Gutter Ponding?	N/A	N/A	Gutter Slope (%)	N/A
N/A	Gutter Lip Ht (in)	N/A	N/A	Gutter X Slope (%)	N/A
N/A	Painted X Walk1?	Yes	N/A	Painted X Walk2?	N/A
	X Walk 1 Direction	To SE		X Walk 2 Direction	N/A
N/A	X Walk 1 Width (in)	120.0	N/A	X Walk 2 Width (in)	N/A
	X Walk 1 Slope (%)	1.0		X Walk 2 Slope (%)	N/A
	X Walk 1 X Slope (%)	2.5		X Walk 2 X Slope (%)	N/A

N/A	Ramp inside XWalk1?	Yes	N/A	Ramp inside XWalk2?	N/A
	Road Slope (%)	N/A	N/A	Clear Space?	N/A
	Road X Slope (%)	N/A	N/A	Clear Space to XWalk (in)	N/A
N/A	Any Obstructions?	N/A	N/A	Storm Grate/Utility Hazard?	N/A
	Obstruction Type			Storm Grate/Utility Type	
		N/A			N/A
			Yes	Surface Condition? (G/P)	Good

**Remove & Replace Entire Ramp.**

Total Cost: \$ 1850.00
