# Access Compliance Report

## Public Rights-of-Way

### (Curb Ramps)

Intersection ID: N/A	Main Street: COSTIGAN_LN	Cross Street: N/A	Location: SE
ADA ID: 790EEA43A32C	Ramp Type: Perp	Initial Pass/Fail: Fail	Overall Compliance: No
Severity Score: 60			
Codes/Mitigation Info/Possible Solution		Field Measurements/Component Compliance

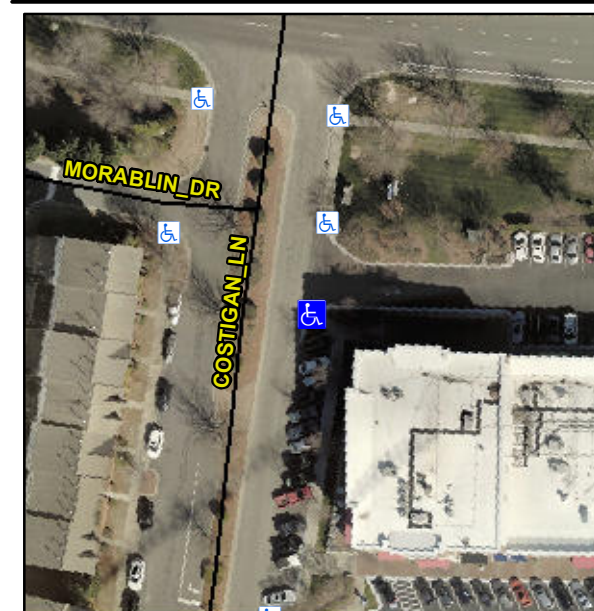
**Not Found, R304.5.1, R304.2.2, R304.5.3**

Compliance	Description	Data	Compliance	Description	Data
N/A	Ramp Length (in)	48.0	No	Ramp Slope (%)	9.9
No	Ramp Width (in)	30.0	No	Ramp XSlope (%)	5.6
N/A	Flare Type LT	N/A	N/A	Flare Type RT	N/A
N/A	Flare Slope LT (%)	N/A	N/A	Flare Slope RT (%)	N/A
N/A	Flare Traversable LT?	N/A	N/A	Flare Traversable RT?	N/A
N/A	Landing Length (in)	N/A	N/A	DWS Provided?	N/A
N/A	Landing Width (in)	N/A	N/A	DWS Contrast?	N/A
N/A	Landing Slope (%)	N/A	N/A	DWS Length (in)	N/A
N/A	Landing X Slope (%)	N/A	N/A	DWS Full Width?	N/A
N/A	Landing Curb? (Y/N)	N/A	N/A	DWS Offset (in)	N/A
N/A	Shared Landing?	N/A			
N/A	Gutter Ponding?	N/A	N/A	Gutter Slope (%)	N/A
N/A	Gutter Lip Ht (in)	N/A	N/A	Gutter X Slope (%)	N/A
N/A	Painted X Walk1?	No	N/A	Painted X Walk2?	N/A
	X Walk 1 Direction	To NE		X Walk 2 Direction	N/A
N/A	X Walk 1 Width (in)	N/A	N/A	X Walk 2 Width (in)	N/A
	X Walk 1 Slope (%)	6.1		X Walk 2 Slope (%)	N/A
	X Walk 1 X Slope (%)	6.8		X Walk 2 X Slope (%)	N/A

Possible Solutions:

**Remove & Replace Entire Ramp.**
