# Access Compliance Report

## Public Rights-of-Way

### (Curb Ramps)

Intersection ID: 50585	Main Street: GRAND_FIR_RD	Cross Street: BENDING_BRANCH_RD	Location: NW
ADA ID: 790FE433EC04	Ramp Type: Perp	Initial Pass/Fail: Fail	Overall Compliance: No
Severity Score: 21.25			
Codes/Mitigation Info/Possible Solution		Field Measurements/Component Compliance

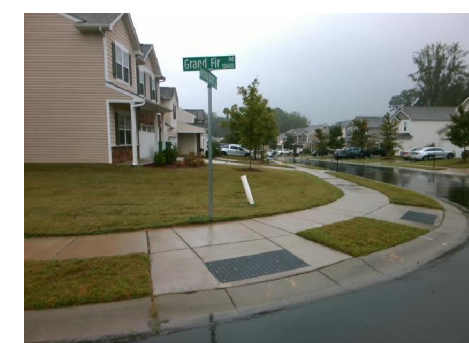
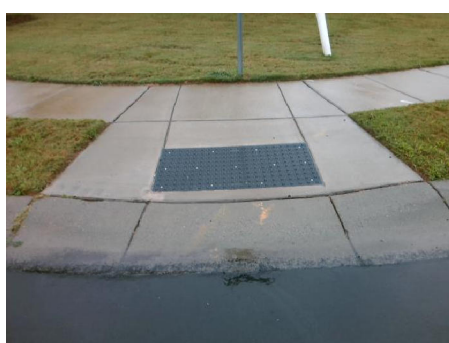
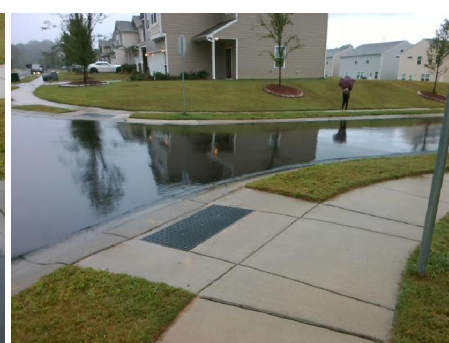
Compliance	Description	Data	Compliance	Description	Data
N/A	Ramp Length (in)	49.5	No	Ramp Slope (%)	11.2
No	Ramp Width (in)	46.5	Yes	Ramp XSlope (%)	1.0
N/A	Flare Type LT	N/A	N/A	Flare Type RT	N/A
N/A	Flare Slope LT (%)	N/A	N/A	Flare Slope RT (%)	N/A
N/A	Flare Traversable LT?	N/A	N/A	Flare Traversable RT?	N/A
N/A	Landing Length (in)	N/A	N/A	DWS Provided?	N/A
N/A	Landing Width (in)	N/A	N/A	DWS Contrast?	N/A
N/A	Landing Slope (%)	N/A	N/A	DWS Length (in)	N/A
N/A	Landing X Slope (%)	N/A	N/A	DWS Full Width?	N/A
N/A	Landing Curb? (Y/N)	N/A	N/A	DWS Offset (in)	N/A
N/A	Shared Landing?	N/A			
N/A	Gutter Ponding?	N/A	N/A	Gutter Slope (%)	N/A
N/A	Gutter Lip Ht (in)	N/A	N/A	Gutter X Slope (%)	N/A
N/A	Painted X Walk1?	No	N/A	Painted X Walk2?	N/A
	X Walk 1 Direction	To S		X Walk 2 Direction	N/A
N/A	X Walk 1 Width (in)	N/A	N/A	X Walk 2 Width (in)	N/A
	X Walk 1 Slope (%)	2.2		X Walk 2 Slope (%)	N/A
	X Walk 1 X Slope (%)	1.2		X Walk 2 X Slope (%)	N/A

N/A	Ramp inside XWalk1?	N/A	N/A	Ramp inside XWalk2?	N/A
	Road Slope (%)	N/A	N/A	Clear Space?	N/A
	Road X Slope (%)	N/A	N/A	Clear Space to XWalk (in)	N/A
N/A	Any Obstructions?	N/A	N/A	Storm Grate/Utility Hazard?	N/A
	Obstruction Type			Storm Grate/Utility Type	
		N/A			N/A
			Yes	Surface Condition? (G/P)	Good

Possible Solutions:

**Remove & Replace Entire Ramp.**
