Access Compliance Report

Public Rights-of-Way

(Curb Ramps)

Intersection ID: 18844	Main Street: NATIONS_FORD_RD	Cross Street: TYVOLA_RD	Location: SE
ADA ID: 79165778E5C4	Ramp Type: PerpDiag	Initial Pass/Fail: Fail	Overall Compliance: No
Severity Score: 13.75			
Codes/Mitigation Info/Possible Solution		Field Measurements/Component Compliance

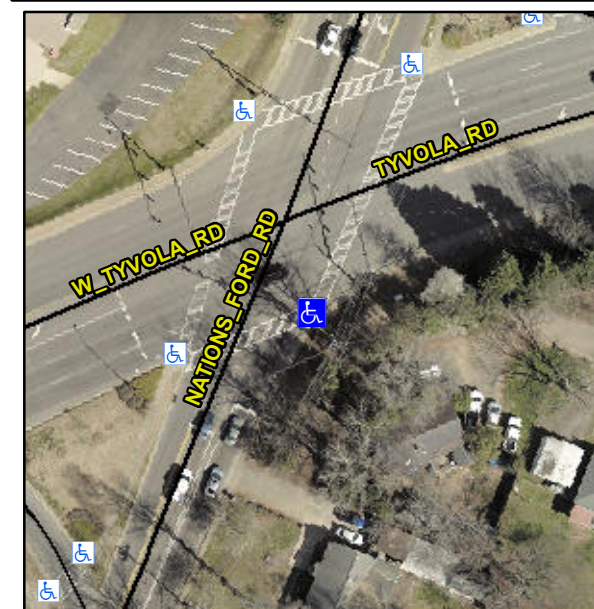
Compliance	Description	Data	Compliance	Description	Data
N/A	Ramp Length (in)	48.0	No	Ramp Slope (%)	9.2
Yes	Ramp Width (in)	48.0	No	Ramp XSlope (%)	2.5
N/A	Flare Type LT	N/A	N/A	Flare Type RT	N/A
N/A	Flare Slope LT (%)	N/A	N/A	Flare Slope RT (%)	N/A
N/A	Flare Traversable LT?	N/A	N/A	Flare Traversable RT?	N/A
N/A	Landing Length (in)	N/A	N/A	DWS Provided?	N/A
N/A	Landing Width (in)	N/A	N/A	DWS Contrast?	N/A
N/A	Landing Slope (%)	N/A	N/A	DWS Length (in)	N/A
N/A	Landing X Slope (%)	N/A	N/A	DWS Full Width?	N/A
N/A	Landing Curb? (Y/N)	N/A	N/A	DWS Offset (in)	N/A
N/A	Shared Landing?	N/A			
N/A	Gutter Ponding?	N/A	N/A	Gutter Slope (%)	N/A
N/A	Gutter Lip Ht (in)	N/A	N/A	Gutter X Slope (%)	N/A
N/A	Painted X Walk1?	Yes	N/A	Painted X Walk2?	Yes
	X Walk 1 Direction	To NE		X Walk 2 Direction	To W
N/A	X Walk 1 Width (in)	80.0	N/A	X Walk 2 Width (in)	84.0
	X Walk 1 Slope (%)	0.6		X Walk 2 Slope (%)	1.4
	X Walk 1 X Slope (%)	0.4		X Walk 2 X Slope (%)	1.8

N/A	Ramp inside XWalk1?	Yes	N/A	Ramp inside XWalk2?	Yes
	Road Slope (%)	0.5	N/A	Clear Space?	N/A
	Road X Slope (%)	1.1	N/A	Clear Space to XWalk (in)	N/A
N/A	Any Obstructions?	N/A	N/A	Storm Grate/Utility Hazard?	N/A
	Obstruction Type			Storm Grate/Utility Type	
		N/A			N/A
		Yes		Surface Condition? (G/P)	Good

Remove & Replace Curb Ramp With Two New Directional Ramps or Equivalent.

R304.2.2, R304.5.3
