Access Compliance Report

Public Rights-of-Way

(Curb Ramps)

Intersection ID: 18726	Main Street: TYVOLA_RD	Cross Street: OLD_PINEVILLE_RD	Location: SE
ADA ID: 7916C329250A	Ramp Type: Perp	Initial Pass/Fail: Fail	Overall Compliance: No
Severity Score: 8.75			
Codes/Mitigation Info/Possible Solution		Field Measurements/Component Compliance

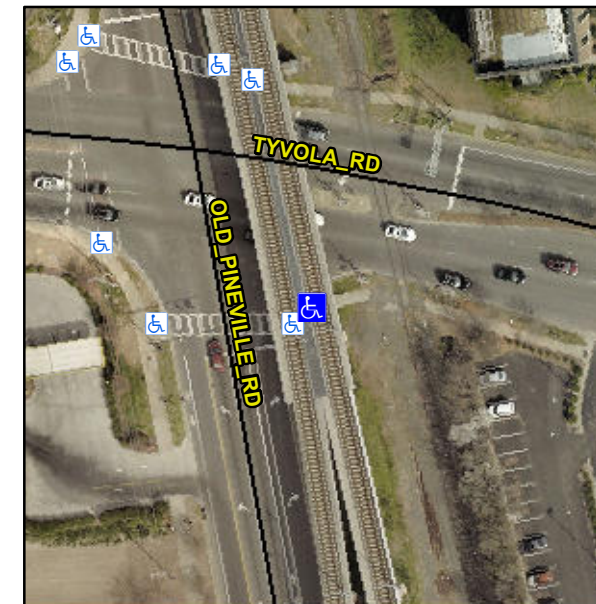
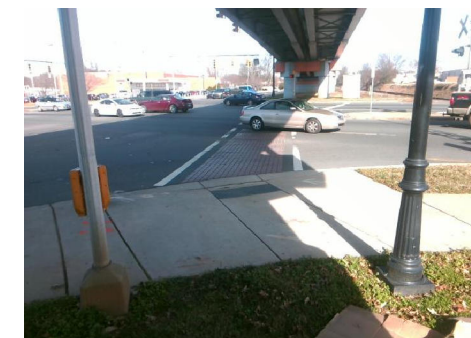
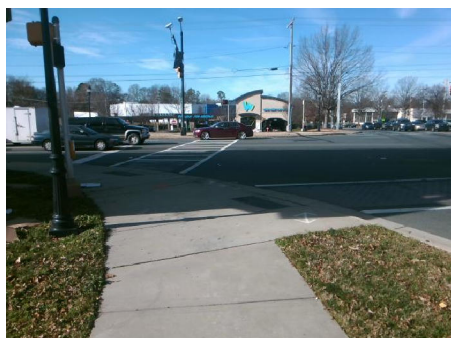
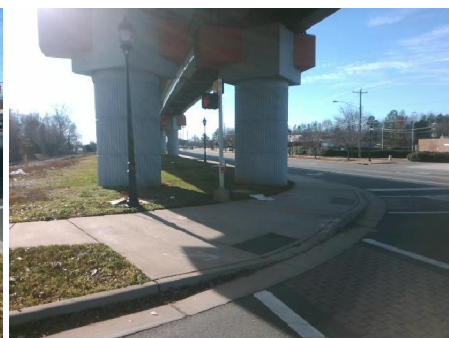
Not Found, R304.5.1

Compliance	Description	Data	Compliance	Description	Data
N/A	Ramp Length (in)	137.0	Yes	Ramp Slope (%)	6.5
No	Ramp Width (in)	47.0	Yes	Ramp XSlope (%)	2.0
N/A	Flare Type LT	N/A	N/A	Flare Type RT	N/A
N/A	Flare Slope LT (%)	N/A	N/A	Flare Slope RT (%)	N/A
N/A	Flare Traversable LT?	N/A	N/A	Flare Traversable RT?	N/A
N/A	Landing Length (in)	N/A	N/A	DWS Provided?	N/A
N/A	Landing Width (in)	N/A	N/A	DWS Contrast?	N/A
N/A	Landing Slope (%)	N/A	N/A	DWS Length (in)	N/A
N/A	Landing X Slope (%)	N/A	N/A	DWS Full Width?	N/A
N/A	Landing Curb? (Y/N)	N/A	N/A	DWS Offset (in)	N/A
N/A	Shared Landing?	N/A			
N/A	Gutter Ponding?	N/A	N/A	Gutter Slope (%)	N/A
N/A	Gutter Lip Ht (in)	N/A	N/A	Gutter X Slope (%)	N/A
N/A	Painted X Walk1?	Yes	N/A	Painted X Walk2?	N/A
	X Walk 1 Direction	To N		X Walk 2 Direction	N/A
N/A	X Walk 1 Width (in)	105.0	N/A	X Walk 2 Width (in)	N/A
	X Walk 1 Slope (%)	1.6		X Walk 2 Slope (%)	N/A
	X Walk 1 X Slope (%)	0.6		X Walk 2 X Slope (%)	N/A

N/A	Ramp inside XWalk1?	Yes	N/A	Ramp inside XWalk2?	N/A
	Road Slope (%)	N/A	N/A	Clear Space?	N/A
	Road X Slope (%)	N/A	N/A	Clear Space to XWalk (in)	N/A
N/A	Any Obstructions?	N/A	N/A	Storm Grate/Utility Hazard?	N/A
	Obstruction Type			Storm Grate/Utility Type	
		N/A			N/A
		Yes		Surface Condition? (G/P)	Good

Remove & Replace Entire Ramp.

Total Cost: \$ 1850.00
