Access Compliance Report

Public Rights-of-Way

(Curb Ramps)

Intersection ID: 28068	Main Street: BORCHETTA_DR	Cross Street: MITCHELL_GLEN_DR	Location: NE
ADA ID: 792D2CA1AB99	Ramp Type: Perp	Initial Pass/Fail: Fail	Overall Compliance: No
Severity Score: 37.5			
Codes/Mitigation Info/Possible Solution		Field Measurements/Component Compliance

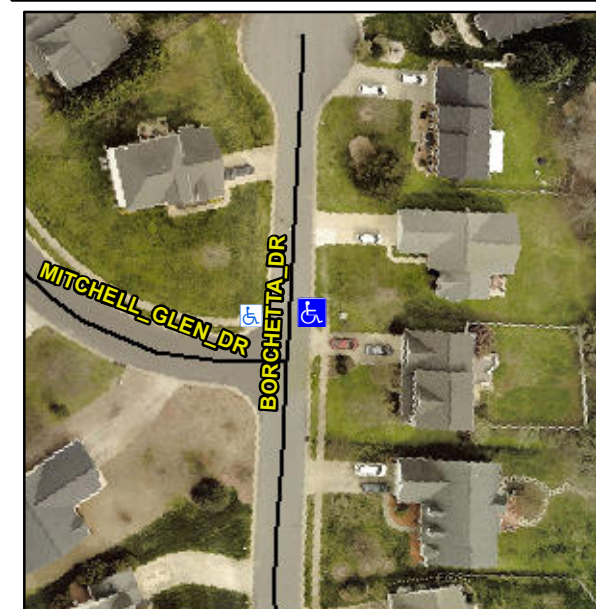
Compliance	Description	Data	Compliance	Description	Data
N/A	Ramp Length (in)	95.0	No	Ramp Slope (%)	10.2
Yes	Ramp Width (in)	48.0	No	Ramp XSlope (%)	8.1
N/A	Flare Type LT	N/A	N/A	Flare Type RT	N/A
N/A	Flare Slope LT (%)	N/A	N/A	Flare Slope RT (%)	N/A
N/A	Flare Traversable LT?	N/A	N/A	Flare Traversable RT?	N/A
N/A	Landing Length (in)	N/A	N/A	DWS Provided?	N/A
N/A	Landing Width (in)	N/A	N/A	DWS Contrast?	N/A
N/A	Landing Slope (%)	N/A	N/A	DWS Length (in)	N/A
N/A	Landing X Slope (%)	N/A	N/A	DWS Full Width?	N/A
N/A	Landing Curb? (Y/N)	N/A	N/A	DWS Offset (in)	N/A
N/A	Shared Landing?	N/A			
N/A	Gutter Ponding?	N/A	N/A	Gutter Slope (%)	N/A
N/A	Gutter Lip Ht (in)	N/A	N/A	Gutter X Slope (%)	N/A
N/A	Painted X Walk1?	No	N/A	Painted X Walk2?	N/A
	X Walk 1 Direction	To NW		X Walk 2 Direction	N/A
N/A	X Walk 1 Width (in)	N/A	N/A	X Walk 2 Width (in)	N/A
	X Walk 1 Slope (%)	2.7		X Walk 2 Slope (%)	N/A
	X Walk 1 X Slope (%)	3.3		X Walk 2 X Slope (%)	N/A

N/A	Ramp inside XWalk1?	N/A	N/A	Ramp inside XWalk2?	N/A
	Road Slope (%)	N/A	N/A	Clear Space?	N/A
	Road X Slope (%)	N/A	N/A	Clear Space to XWalk (in)	N/A
N/A	Any Obstructions?	N/A	N/A	Storm Grate/Utility Hazard?	N/A
	Obstruction Type			Storm Grate/Utility Type	
		N/A			N/A
			Yes	Surface Condition? (G/P)	Good

Possible Solutions:

Remove & Replace Entire Ramp.

R304.2.2, R304.5.3
