Access Compliance Report

Public Rights-of-Way

(Curb Ramps)

| Intersection ID: 23162 | Main Street: SHARON_RD_WEST | Cross Street: SOUTH_BV | Location: SW |

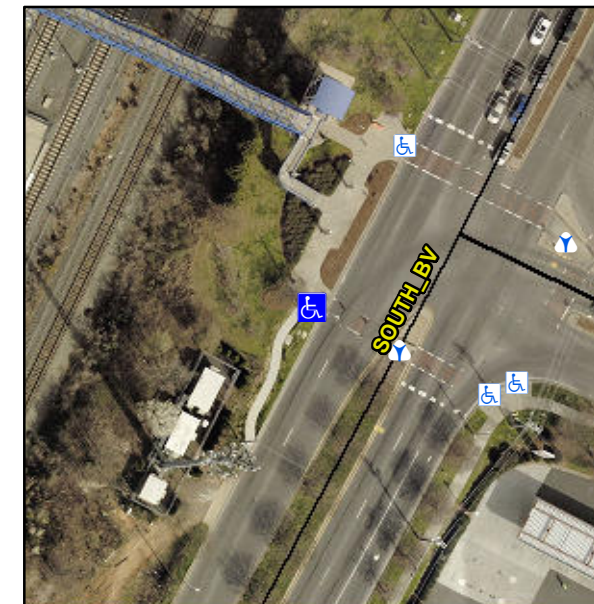
| ADA ID: 792E4CE54177 | Ramp Type: BlendTrans1 | Initial Pass/Fail: Fail | Overall Compliance: No |
| | | Severity Score: 8.75 | |

Not Found, R304.5.1

| Compliance | Description | Data | Compliance | Description | Data |
|---|---|---|---|---|---|
| No | Ramp Width (in) | 47.5 | Yes | BlendTrans XSlope (%) | 1.5 |
| | | | No | Curb Slope (%) | 15.5 |

Remove & Replace Curb Ramp With Two New Directional Ramps or Equivalent.

Total Cost: \$ 3200.00
