Access Compliance Report

Public Rights-of-Way

(Curb Ramps)

Intersection ID: 3985	Main Street: ARMITAGE_DR	Cross Street: WOLF_CREEK_TL	Location:	N
ADA ID: 792FA77755B6	Ramp Type: BlendTrans1	Initial Pass/Fail: Fail	Overall Compliance: No	Severity Score: 10
Codes/Mitigation Info/Possible Solution		Field Measurements/Component Compliance

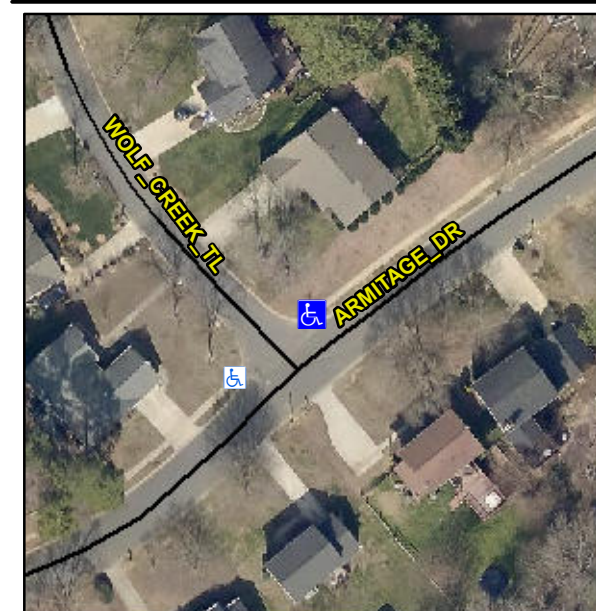
Not Found, R304.5.1, R304.5.3

Compliance	Description	Data	Compliance	Description	Data
N/A	Ramp Length (in)	56.0	Yes	BlendTrans Slope (%)	3.4
No	Ramp Width (in)	46.0	No	BlendTrans XSlope (%)	4.8
N/A	Flare Type LT	N/A	N/A	Flare Type RT	N/A
N/A	Flare Slope LT (%)	N/A	N/A	Flare Slope RT (%)	N/A
N/A	Flare Traversable LT?	N/A	N/A	Flare Traversable RT?	N/A
N/A	Landing Length (in)	N/A	N/A	DWS Provided?	N/A
N/A	Landing Width (in)	N/A	N/A	DWS Contrast?	N/A
N/A	Landing Slope (%)	N/A	N/A	DWS Length (in)	N/A
N/A	Landing X Slope (%)	N/A	N/A	DWS Full Width?	N/A
N/A	Landing Curb? (Y/N)	N/A	N/A	DWS Offset (in)	N/A
N/A	Shared Landing?	N/A			
N/A	Gutter Ponding?	N/A	N/A	Gutter Slope (%)	N/A
N/A	Gutter Lip Ht (in)	N/A	N/A	Gutter X Slope (%)	N/A
N/A	Painted X Walk1?	No	N/A	Painted X Walk2?	N/A
	X Walk 1 Direction	To SW		X Walk 2 Direction	N/A
	X Walk 1 Width (in)	N/A		X Walk 2 Width (in)	N/A
	X Walk 1 Slope (%)	2.5		X Walk 2 Slope (%)	N/A
	X Walk 1 X Slope (%)	2.9		X Walk 2 X Slope (%)	N/A

N/A	Ramp inside XWalk1?	N/A	N/A	Ramp inside XWalk2?	N/A
	Road Slope (%)	2.9		Clear Space?	N/A
	Road X Slope (%)	2.5	N/A	Clear Space to XWalk (in)	N/A
N/A	Any Obstructions?	N/A	N/A	Storm Grate/Utility Hazard?	N/A
	Obstruction Type			Storm Grate/Utility Type	
		N/A			N/A
			Yes	Surface Condition? (G/P)	Good
			No	Curb Slope (%)	17.1

Remove & Replace Curb Ramp With Two New Directional Ramps or Equivalent.
