# Access Compliance Report

## Public Rights-of-Way

### (Curb Ramps)

| Intersection ID: 53758 | Main Street: PROSPERITY RIDGE RD | Cross Street: PROSPERITY RIDGE RD | Location: W |

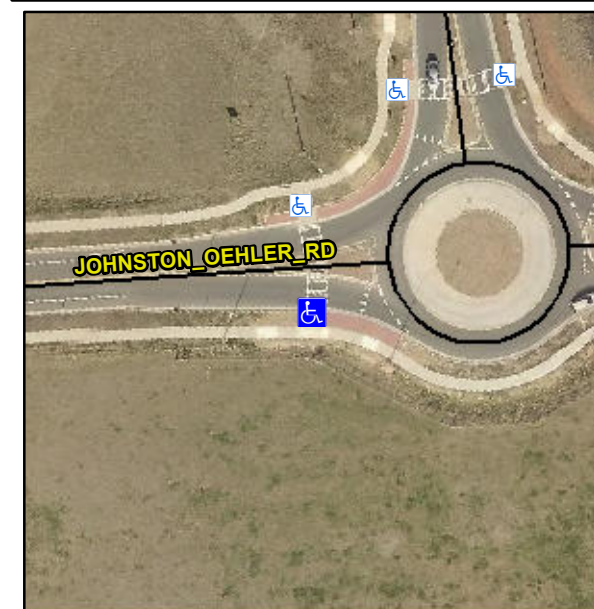
**R304.2.2-Perp, R304.3.2-Para,  
R304.5.3, R305.2**

| Compliance | Description | Data | Compliance | Description | Data |
|---|---|---|---|---|---|
| No | Landing Slope (%) | 3.4 | Yes | DWS Length (in) | 24.0 |
| No | Landing X Slope (%) | 2.7 | Yes | DWS Full Width? | Yes |
| N/A | Landing Curb? (Y/N) | No | No | DWS Offset (in) | 6.0 |

**Remove & Replace Entire Ramp.**

Total Cost: \$ 1850.00
