# Access Compliance Report

## Public Rights-of-Way

### (Curb Ramps)

Intersection ID: 27288	Main Street: PIPER_STATION_DR	Cross Street: REA_RD	Location: SE
ADA ID: 793876AB07D3	Ramp Type: Perp	Initial Pass/Fail: Fail	Overall Compliance: No
Codes/Mitigation Info/Possible Solution		Field Measurements/Component Compliance	
Severity Score: 8.75

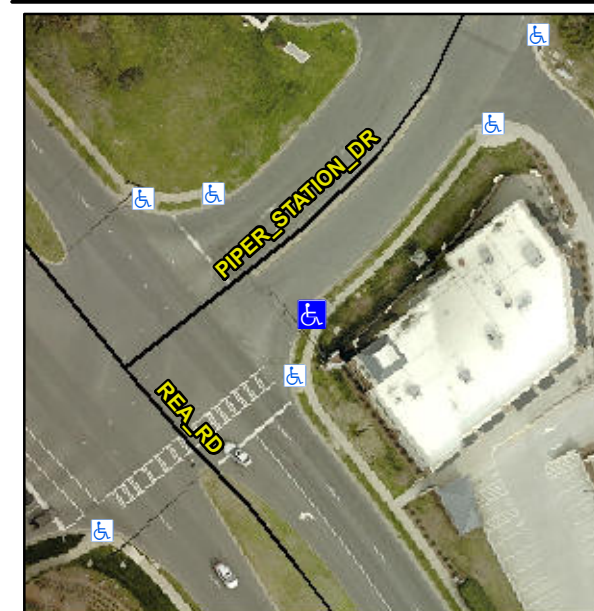
**Not Found, R304.5.1**

Compliance	Description	Data	Compliance	Description	Data
N/A	Ramp Length (in)	53.0	Yes	Ramp Slope (%)	7.4
No	Ramp Width (in)	41.0	Yes	Ramp XSlope (%)	1.5
N/A	Flare Type LT	N/A	N/A	Flare Type RT	N/A
N/A	Flare Slope LT (%)	N/A	N/A	Flare Slope RT (%)	N/A
N/A	Flare Traversable LT?	N/A	N/A	Flare Traversable RT?	N/A
N/A	Landing Length (in)	N/A	N/A	DWS Provided?	N/A
N/A	Landing Width (in)	N/A	N/A	DWS Contrast?	N/A
N/A	Landing Slope (%)	N/A	N/A	DWS Length (in)	N/A
N/A	Landing X Slope (%)	N/A	N/A	DWS Full Width?	N/A
N/A	Landing Curb? (Y/N)	N/A	N/A	DWS Offset (in)	N/A
N/A	Shared Landing?	N/A			
N/A	Gutter Ponding?	N/A	N/A	Gutter Slope (%)	N/A
N/A	Gutter Lip Ht (in)	N/A	N/A	Gutter X Slope (%)	N/A
N/A	Painted X Walk1?	No	N/A	Painted X Walk2?	N/A
	X Walk 1 Direction	To NW		X Walk 2 Direction	N/A
N/A	X Walk 1 Width (in)	N/A	N/A	X Walk 2 Width (in)	N/A
	X Walk 1 Slope (%)	3.2		X Walk 2 Slope (%)	N/A
	X Walk 1 X Slope (%)	0.4		X Walk 2 X Slope (%)	N/A

N/A	Ramp inside XWalk1?	N/A	N/A	Ramp inside XWalk2?	N/A
	Road Slope (%)	N/A	N/A	Clear Space?	N/A
	Road X Slope (%)	N/A	N/A	Clear Space to XWalk (in)	N/A
N/A	Any Obstructions?	N/A	N/A	Storm Grate/Utility Hazard?	N/A
	Obstruction Type			Storm Grate/Utility Type	
		N/A			N/A
			Yes	Surface Condition? (G/P)	Good

**Remove & Replace Entire Ramp.**

Total Cost: \$ 1850.00
