# Access Compliance Report

## Public Rights-of-Way

### (Curb Ramps)

Intersection ID: 53624	Main Street: PROSPERITY RIDGE RD	Cross Street: RIDGE RD	Location: SE
ADA ID: 793A3D90C770	Ramp Type: Perp	Initial Pass/Fail: Fail	Overall Compliance: No
			Severity Score: 21.25

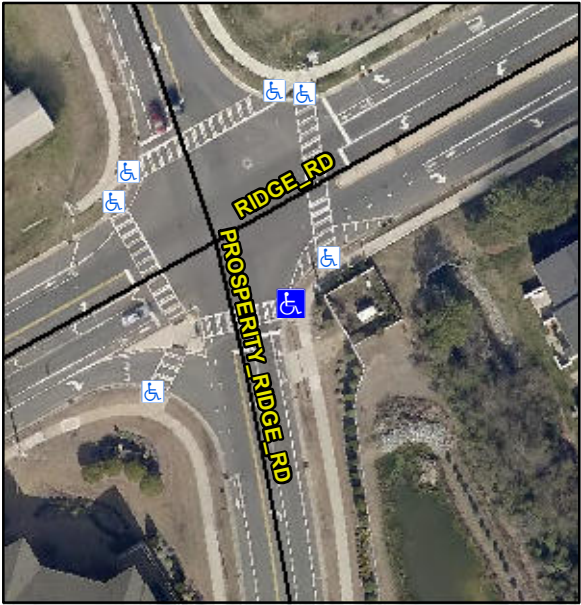
Possible Solutions:		<b>Compliance</b>	<b>Description</b>	<b>Data</b>
	Remove & Replace Entire Ramp.		N/A	Ramp Length (in)	50.5
			No	Ramp Width (in)	47.0
			N/A	Flare Type LT	N/A
			N/A	Flare Slope LT (%)	N/A
			N/A	Flare Traversable LT?	N/A
			N/A	Landing Length (in)	N/A
			N/A	Landing Width (in)	N/A
			N/A	Landing Slope (%)	N/A
			N/A	Landing X Slope (%)	N/A
<p>Surveyor Notes:</p> <p>N/A</p> <p>PROW/ADA:</p> <p>R304.5.1, R304.2.2</p>			N/A	Flare Type RT	N/A
			N/A	Flare Slope RT (%)	N/A
			N/A	Flare Traversable RT?	N/A
			N/A	DWS Provided?	N/A
			N/A	DWS Contrast?	N/A
			N/A	DWS Length (in)	N/A
			N/A	DWS Full Width?	N/A
			N/A	DWS Offset (in)	N/A
			N/A	Shared Landing?	N/A
			N/A	Gutter Ponding?	N/A
			N/A	Gutter Lip Ht (in)	N/A
			N/A	Painted X Walk1?	Yes
				X Walk 1 Direction	To W
			N/A	X Walk 1 Width (in)	112.0
				X Walk 1 Slope (%)	2.5

X Walk 1 X Slope (%)	0.3
			N/A	Ramp inside XWalk1?	Yes
				Road Slope (%)	N/A
				Road X Slope (%)	N/A
			N/A	Any Obstructions?	N/A
				Obstruction Type	
Total Cost:		\$ 1850.00			
			N/A		N/A
			Yes	Surface Condition? (G/P)	Good
