# Access Compliance Report

## Public Rights-of-Way

| Intersection ID: 29398 | Main Street: FARNSWORTH_LN | Cross Street: GOLD_PAN_RD | Location: SE |
| ADA ID: 793C1C3F3462 | Ramp Type: BlendTrans1 | Initial Pass/Fail: Pass | Overall Compliance: No |

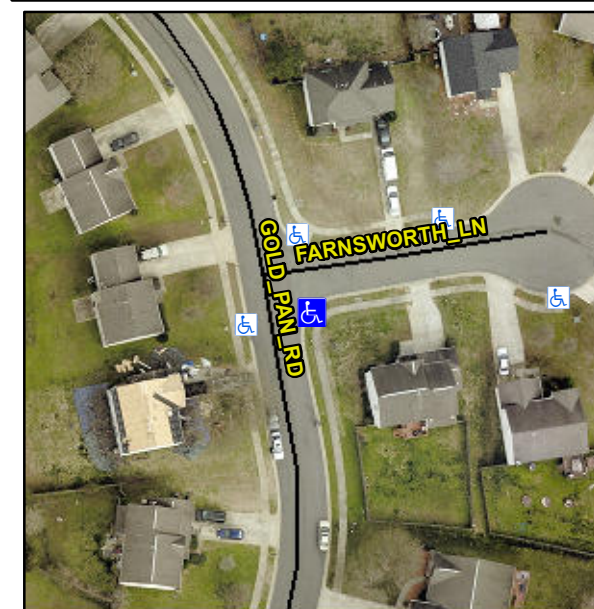
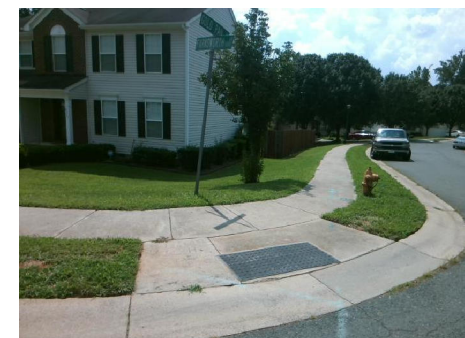
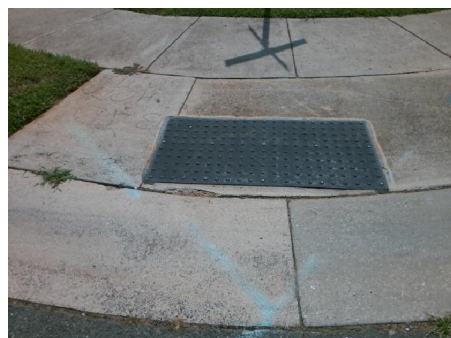
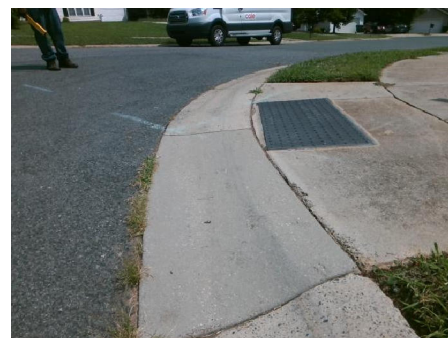
**Not Found, R304.2.2-Perp, R304.3.2-Para, R305.2**

| Compliance | Description | Data | Compliance | Description | Data |
|---|---|---|---|---|---|
| No | Landing Slope (%) | 2.8 | Yes | DWS Length (in) | 24.0 |
| N/A | Landing Curb? (Y/N) | No | No | DWS Offset (in) | 3.5 |
| | | | No | Curb Slope (%) | 9.0 |

**Remove & Replace Curb Ramp With Two New Directional Ramps or Equivalent.**
