Access Compliance Report

Public Rights-of-Way

(Curb Ramps)

Intersection ID: 29178	Main Street: HARRIS_CENTER_DR	Cross Street: STATESVILLE_RD	Location: W
ADA ID: 793E898EA492	Ramp Type: Perp	Initial Pass/Fail: Fail	Overall Compliance: No
		Severity Score: 25

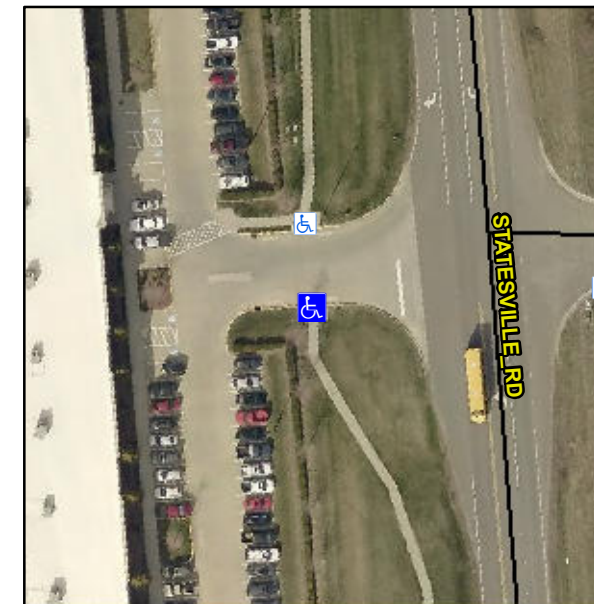
R304.2.2, R304.5.3

Compliance	Description	Data	Compliance	Description	Data
N/A	Ramp Length (in)	98.0	No	Ramp Slope (%)	9.0
Yes	Ramp Width (in)	48.0	No	Ramp XSlope (%)	5.6
N/A	Flare Type LT	N/A	N/A	Flare Type RT	N/A
N/A	Flare Slope LT (%)	N/A	N/A	Flare Slope RT (%)	N/A
N/A	Flare Traversable LT?	N/A	N/A	Flare Traversable RT?	N/A
N/A	Landing Length (in)	N/A	N/A	DWS Provided?	N/A
N/A	Landing Width (in)	N/A	N/A	DWS Contrast?	N/A
N/A	Landing Slope (%)	N/A	N/A	DWS Length (in)	N/A
N/A	Landing X Slope (%)	N/A	N/A	DWS Full Width?	N/A
N/A	Landing Curb? (Y/N)	N/A	N/A	DWS Offset (in)	N/A
N/A	Shared Landing?	N/A			
N/A	Gutter Ponding?	N/A	N/A	Gutter Slope (%)	N/A
N/A	Gutter Lip Ht (in)	N/A	N/A	Gutter X Slope (%)	N/A
N/A	Painted X Walk1?	No	N/A	Painted X Walk2?	N/A
	X Walk 1 Direction	To N		X Walk 2 Direction	N/A
N/A	X Walk 1 Width (in)	N/A	N/A	X Walk 2 Width (in)	N/A
	X Walk 1 Slope (%)	1.7		X Walk 2 Slope (%)	N/A
	X Walk 1 X Slope (%)	5.6		X Walk 2 X Slope (%)	N/A

N/A	Ramp inside XWalk1?	N/A	N/A	Ramp inside XWalk2?	N/A
	Road Slope (%)	N/A	N/A	Clear Space?	N/A
	Road X Slope (%)	N/A	N/A	Clear Space to XWalk (in)	N/A
N/A	Any Obstructions?	N/A	N/A	Storm Grate/Utility Hazard?	N/A
	Obstruction Type			Storm Grate/Utility Type	
		N/A			N/A
			Yes	Surface Condition? (G/P)	Good

Remove & Replace Entire Ramp.
