Access Compliance Report

Public Rights-of-Way

(Curb Ramps)

Intersection ID: N/A	Main Street: E_PETERSON_DR	Cross Street: E_CAMA_ST	Location: NE
ADA ID: 7946C548E703	Ramp Type: ParaDiag	Initial Pass/Fail: Fail	Overall Compliance: No
Codes/Mitigation Info/Possible Solution		Field Measurements/Component Compliance

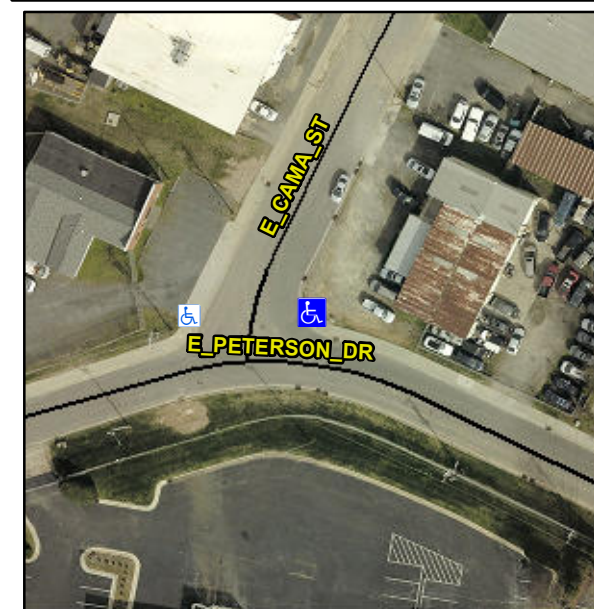
LT RP < 5%

PROW/ADA:

R304.5.3, R304.3.2

Compliance	Description	Data	Compliance	Description	Data
N/A	Ramp Length LT (in)	62.0	N/A	Ramp Length RT (in)	67.0
Yes	Ramp Width LT (in)	71.0	Yes	Ramp Width RT (in)	70.0
Yes	Ramp Slope LT (%)	0.9	No	Ramp Slope RT (%)	9.2
No	Ramp XSlope LT (%)	3.5	No	Ramp XSlope RT (%)	2.1
N/A	Landing Length (in)	N/A	N/A	DWS Provided?	N/A
N/A	Landing Width (in)	N/A	N/A	DWS Contrast?	N/A
N/A	Landing Slope (%)	N/A	N/A	DWS Length (in)	N/A
N/A	Landing X Slope (%)	N/A	N/A	DWS Full Width?	N/A
N/A	Landing Curb? (Y/N)	N/A	N/A	DWS Offset (in)	N/A
N/A	Shared Landing?	N/A			
N/A	Gutter Ponding?	N/A	N/A	Gutter Slope (%)	N/A
N/A	Gutter Lip Ht (in)	N/A	N/A	Gutter X Slope (%)	N/A
N/A	Painted X Walk1?	No	N/A	Painted X Walk2?	No
	X Walk 1 Direction	To W		X Walk 2 Direction	To S
N/A	X Walk 1 Width (in)	N/A	N/A	X Walk 2 Width (in)	N/A
	X Walk 1 Slope (%)	1.6		X Walk 2 Slope (%)	7.3
	X Walk 1 X Slope (%)	6.2		X Walk 2 X Slope (%)	3.4
N/A	Ramp inside XWalk1?	N/A	N/A	Ramp inside XWalk2?	N/A

Road Slope (%)	4.8	N/A	Clear Space?	N/A
	Road X Slope (%)	6.0	N/A	Clear Space to XWalk (in)	N/A
N/A	Any Obstructions?	N/A	N/A	Storm Grate/Utility Hazard?	N/A
	Obstruction Type			Storm Grate/Utility Type	
		N/A			N/A
			Yes	Surface Condition? (G/P)	Good
			N/A	Curb Slope (%)	5.6

Possible Solutions:

Remove & Replace Curb Ramp With Two New Directional Ramps or Equivalent.
