# Access Compliance Report

## Public Rights-of-Way

### (Curb Ramps)

Intersection ID: 48568	Main Street: BRAMBLE RIDGE CT	Cross Street: SALAMANDER RUN LN	Location: NE
ADA ID: 7946E3EAF1FE	Ramp Type: PerpDiag	Initial Pass/Fail: Pass	Overall Compliance: No
Severity Score: 0.25			
Codes/Mitigation Info/Possible Solution		Field Measurements/Component Compliance

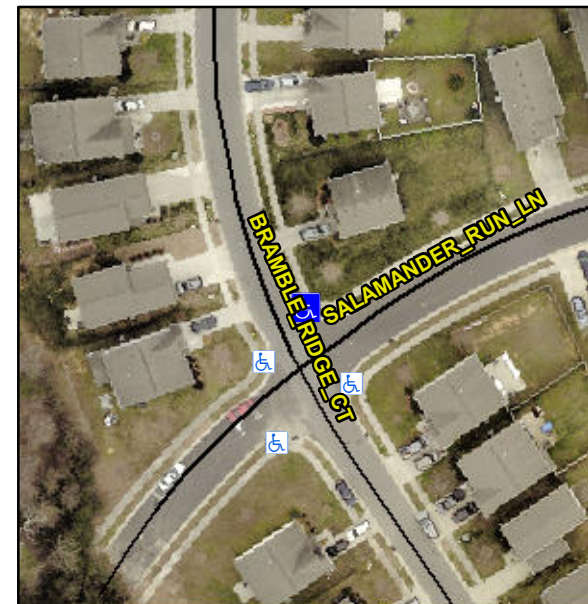
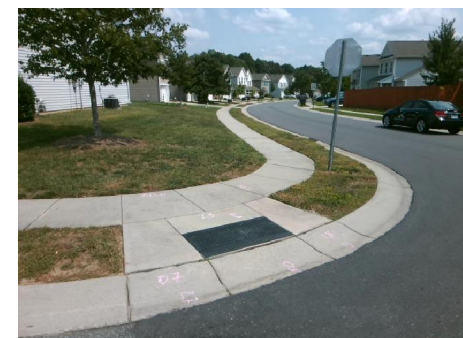
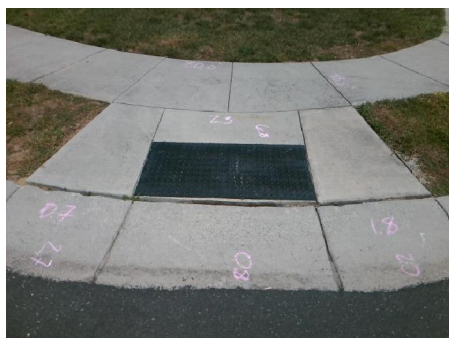
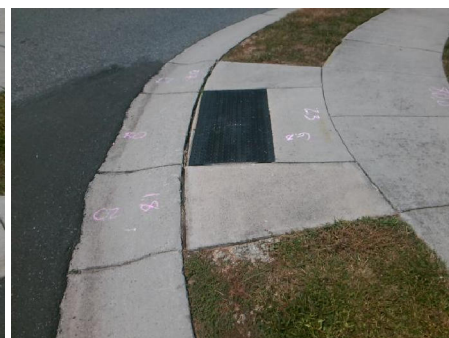
**Not Found, R304.5.3, R305.2**

Compliance	Description	Data	Compliance	Description	Data
N/A	Ramp Length (in)	46.0	Yes	Ramp Slope (%)	6.8
Yes	Ramp Width (in)	48.5	No	Ramp XSlope (%)	2.3
N/A	Flare Type LT	Sloped	N/A	Flare Type RT	N/A
N/A	Flare Slope LT (%)	2.8	N/A	Flare Slope RT (%)	3.5
N/A	Flare Traversable LT?	No	N/A	Flare Traversable RT?	No
Yes	Landing Length (in)	48.5	Yes	DWS Provided?	Yes
Yes	Landing Width (in)	80.0	Yes	DWS Contrast?	Yes
Yes	Landing Slope (%)	1.4	Yes	DWS Length (in)	24.5
No	Landing X Slope (%)	2.8	Yes	DWS Full Width?	Yes
N/A	Landing Curb? (Y/N)	No	No	DWS Offset (in)	3.0
N/A	Shared Landing?	No			
Yes	Gutter Ponding?	No	Yes	Gutter Slope (%)	0.1
Yes	Gutter Lip Ht (in)	0.0	No	Gutter X Slope (%)	2.7
N/A	Painted X Walk1?	No	N/A	Painted X Walk2?	No
	X Walk 1 Direction	To SW		X Walk 2 Direction	To S
N/A	X Walk 1 Width (in)	N/A	N/A	X Walk 2 Width (in)	N/A
	X Walk 1 Slope (%)	2.7		X Walk 2 Slope (%)	2.0
	X Walk 1 X Slope (%)	0.7		X Walk 2 X Slope (%)	1.8

N/A	Ramp inside XWalk1?	N/A	N/A	Ramp inside XWalk2?	N/A
	Road Slope (%)	0.8	N/A	Clear Space?	Yes
	Road X Slope (%)	1.5	N/A	Clear Space to XWalk (in)	N/A
Yes	Any Obstructions?	No	Yes	Storm Grate/Utility Hazard?	No
	Obstruction Type			Storm Grate/Utility Type	
		N/A			N/A
			Yes	Surface Condition? (G/P)	Good

**Remove & Replace Curb Ramp With Two New Directional Ramps or Equivalent. Remove & Replace Gutter.**
