# Access Compliance Report

## Public Rights-of-Way

### (Curb Ramps)

Intersection ID: 11867	Main Street: E_17TH_ST	Cross Street: SEIGLE_AV	Location:	N
ADA ID: 79499FB1AE95	Ramp Type: Perp	Initial Pass/Fail: Fail	Overall Compliance: No	Severity Score: 37.5

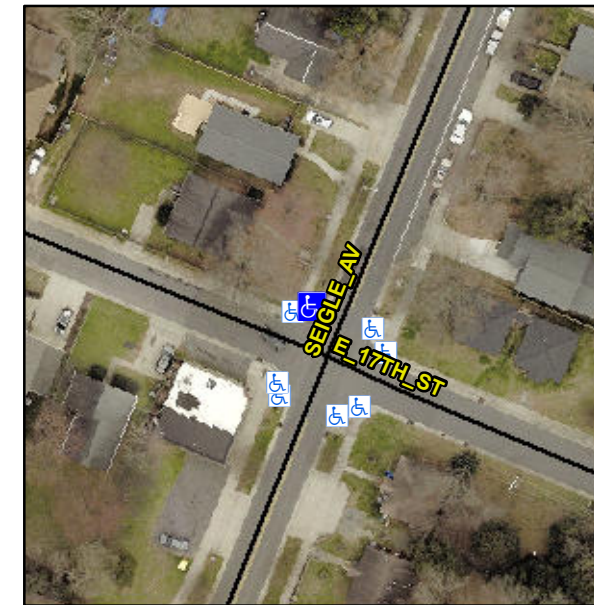
**Not Found, R304.2.2, R304.5.3**

Compliance	Description	Data	Compliance	Description	Data
N/A	Ramp Length (in)	85.0	No	Ramp Slope (%)	9.1
Yes	Ramp Width (in)	48.0	No	Ramp XSlope (%)	7.2
N/A	Flare Type LT	N/A	N/A	Flare Type RT	N/A
N/A	Flare Slope LT (%)	N/A	N/A	Flare Slope RT (%)	N/A
N/A	Flare Traversable LT?	N/A	N/A	Flare Traversable RT?	N/A
N/A	Landing Length (in)	N/A	N/A	DWS Provided?	N/A
N/A	Landing Width (in)	N/A	N/A	DWS Contrast?	N/A
N/A	Landing Slope (%)	N/A	N/A	DWS Length (in)	N/A
N/A	Landing X Slope (%)	N/A	N/A	DWS Full Width?	N/A
N/A	Landing Curb? (Y/N)	N/A	N/A	DWS Offset (in)	N/A
N/A	Shared Landing?	N/A			
N/A	Gutter Ponding?	N/A	N/A	Gutter Slope (%)	N/A
N/A	Gutter Lip Ht (in)	0.5	N/A	Gutter X Slope (%)	N/A
N/A	Painted X Walk1?	No	N/A	Painted X Walk2?	N/A
	X Walk 1 Direction	To SE		X Walk 2 Direction	N/A
N/A	X Walk 1 Width (in)	N/A	N/A	X Walk 2 Width (in)	N/A
	X Walk 1 Slope (%)	1.6		X Walk 2 Slope (%)	N/A
	X Walk 1 X Slope (%)	6.0		X Walk 2 X Slope (%)	N/A

N/A	Ramp inside XWalk1?	N/A	N/A	Ramp inside XWalk2?	N/A
	Road Slope (%)	N/A	N/A	Clear Space?	N/A
	Road X Slope (%)	N/A	N/A	Clear Space to XWalk (in)	N/A
N/A	Any Obstructions?	N/A	N/A	Storm Grate/Utility Hazard?	N/A
	Obstruction Type			Storm Grate/Utility Type	
		N/A			N/A
			Yes	Surface Condition? (G/P)	Good

**Remove & Replace Entire Ramp.**
