# Access Compliance Report

## Public Rights-of-Way

### (Curb Ramps)

Intersection ID: 44484	Main Street: FINN_HALL_AV	Cross Street: NEWFIELD_ST	Location: SW
ADA ID: 794B4E302BA5	Ramp Type: PerpDiag	Initial Pass/Fail: Fail	Overall Compliance: No
		Severity Score: 8.75

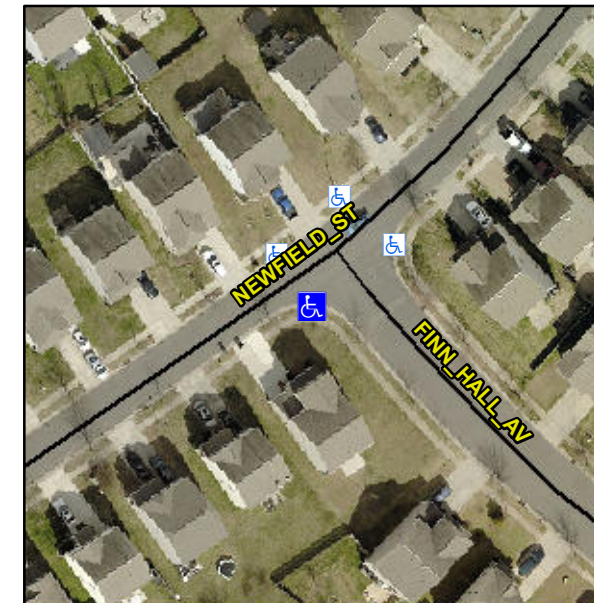
**Not Found, R304.5.1**

Compliance	Description	Data	Compliance	Description	Data
N/A	Ramp Length (in)	49.0	Yes	Ramp Slope (%)	5.7
No	Ramp Width (in)	47.0	Yes	Ramp XSlope (%)	0.1
N/A	Flare Type LT	N/A	N/A	Flare Type RT	N/A
N/A	Flare Slope LT (%)	N/A	N/A	Flare Slope RT (%)	N/A
N/A	Flare Traversable LT?	N/A	N/A	Flare Traversable RT?	N/A
N/A	Landing Length (in)	N/A	N/A	DWS Provided?	N/A
N/A	Landing Width (in)	N/A	N/A	DWS Contrast?	N/A
N/A	Landing Slope (%)	N/A	N/A	DWS Length (in)	N/A
N/A	Landing X Slope (%)	N/A	N/A	DWS Full Width?	N/A
N/A	Landing Curb? (Y/N)	N/A	N/A	DWS Offset (in)	N/A
N/A	Shared Landing?	N/A			
N/A	Gutter Ponding?	N/A	N/A	Gutter Slope (%)	N/A
N/A	Gutter Lip Ht (in)	N/A	N/A	Gutter X Slope (%)	N/A
N/A	Painted X Walk1?	No	N/A	Painted X Walk2?	No
	X Walk 1 Direction	To E		X Walk 2 Direction	To N
N/A	X Walk 1 Width (in)	N/A	N/A	X Walk 2 Width (in)	N/A
	X Walk 1 Slope (%)	2.3		X Walk 2 Slope (%)	2.4
	X Walk 1 X Slope (%)	1.4		X Walk 2 X Slope (%)	2.3

N/A	Ramp inside XWalk1?	N/A	N/A	Ramp inside XWalk2?	N/A
	Road Slope (%)	0.9	N/A	Clear Space?	N/A
	Road X Slope (%)	3.3	N/A	Clear Space to XWalk (in)	N/A
N/A	Any Obstructions?	N/A	N/A	Storm Grate/Utility Hazard?	N/A
	Obstruction Type			Storm Grate/Utility Type	
		N/A			N/A
			Yes	Surface Condition? (G/P)	Good

**Remove & Replace Curb Ramp With Two New Directional Ramps or Equivalent.**
