Access Compliance Report

Public Rights-of-Way

(Curb Ramps)

Intersection ID: 42401	Main Street: GRIERS GROVE RD	Cross Street: MCALLISTER DR	Location: SE
ADA ID: 79522730D6FD	Ramp Type: PerpDiag	Initial Pass/Fail: Fail	Overall Compliance: No
Severity Score: 47.5			
Codes/Mitigation Info/Possible Solution		Field Measurements/Component Compliance

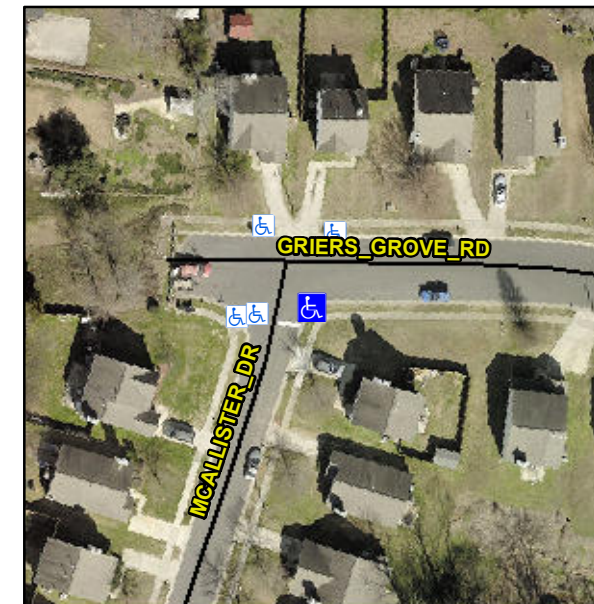
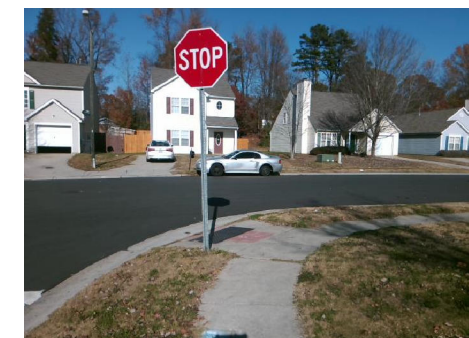
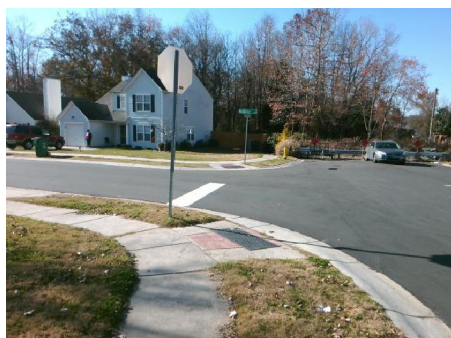
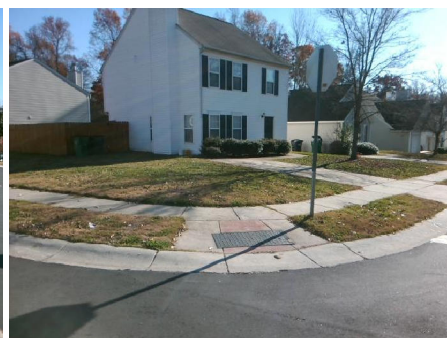
Not Found, R304.5.1, R304.2.2

Compliance	Description	Data	Compliance	Description	Data
N/A	Ramp Length (in)	57.0	No	Ramp Slope (%)	8.4
No	Ramp Width (in)	30.0	Yes	Ramp XSlope (%)	1.5
N/A	Flare Type LT	N/A	N/A	Flare Type RT	N/A
N/A	Flare Slope LT (%)	N/A	N/A	Flare Slope RT (%)	N/A
N/A	Flare Traversable LT?	N/A	N/A	Flare Traversable RT?	N/A
N/A	Landing Length (in)	N/A	N/A	DWS Provided?	N/A
N/A	Landing Width (in)	N/A	N/A	DWS Contrast?	N/A
N/A	Landing Slope (%)	N/A	N/A	DWS Length (in)	N/A
N/A	Landing X Slope (%)	N/A	N/A	DWS Full Width?	N/A
N/A	Landing Curb? (Y/N)	N/A	N/A	DWS Offset (in)	N/A
N/A	Shared Landing?	N/A			
N/A	Gutter Ponding?	N/A	N/A	Gutter Slope (%)	N/A
N/A	Gutter Lip Ht (in)	N/A	N/A	Gutter X Slope (%)	N/A
N/A	Painted X Walk1?	No	N/A	Painted X Walk2?	No
	X Walk 1 Direction	To W		X Walk 2 Direction	To N
N/A	X Walk 1 Width (in)	N/A	N/A	X Walk 2 Width (in)	N/A
	X Walk 1 Slope (%)	2.2		X Walk 2 Slope (%)	1.1
	X Walk 1 X Slope (%)	0.1		X Walk 2 X Slope (%)	3.1

N/A	Ramp inside XWalk1?	N/A	N/A	Ramp inside XWalk2?	N/A
	Road Slope (%)	2.4	N/A	Clear Space?	N/A
	Road X Slope (%)	3.1	N/A	Clear Space to XWalk (in)	N/A
N/A	Any Obstructions?	N/A	N/A	Storm Grate/Utility Hazard?	N/A
	Obstruction Type			Storm Grate/Utility Type	
		N/A			N/A
		Yes		Surface Condition? (G/P)	Good

Remove & Replace Curb Ramp With Two New Directional Ramps or Equivalent.
