# Access Compliance Report

## Public Rights-of-Way

### (Curb Ramps)

Intersection ID: 46765	Main Street: FRIENDSHIP_VILLAGE_PL	Cross Street: MISSIONARY_AV	Location: SE
ADA ID: 7956962A1976	Ramp Type: PerpDiag	Initial Pass/Fail: Fail	Overall Compliance: No
Severity Score: 22.5			
Codes/Mitigation Info/Possible Solution		Field Measurements/Component Compliance

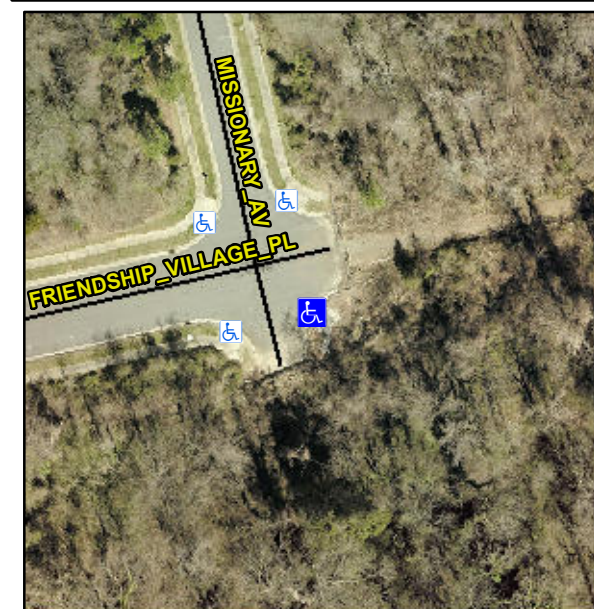
**Not Found, R304.5.1, R304.2.2**

Compliance	Description	Data	Compliance	Description	Data
N/A	Ramp Length (in)	73.5	No	Ramp Slope (%)	10.7
No	Ramp Width (in)	37.5	Yes	Ramp XSlope (%)	3.2
N/A	Flare Type LT	N/A	N/A	Flare Type RT	N/A
N/A	Flare Slope LT (%)	N/A	N/A	Flare Slope RT (%)	N/A
N/A	Flare Traversable LT?	N/A	N/A	Flare Traversable RT?	N/A
N/A	Landing Length (in)	N/A	N/A	DWS Provided?	N/A
N/A	Landing Width (in)	N/A	N/A	DWS Contrast?	N/A
N/A	Landing Slope (%)	N/A	N/A	DWS Length (in)	N/A
N/A	Landing X Slope (%)	N/A	N/A	DWS Full Width?	N/A
N/A	Landing Curb? (Y/N)	N/A	N/A	DWS Offset (in)	N/A
N/A	Shared Landing?	N/A			
N/A	Gutter Ponding?	N/A	N/A	Gutter Slope (%)	N/A
N/A	Gutter Lip Ht (in)	N/A	N/A	Gutter X Slope (%)	N/A
N/A	Painted X Walk1?	No	N/A	Painted X Walk2?	No
	X Walk 1 Direction	To N		X Walk 2 Direction	To W
N/A	X Walk 1 Width (in)	N/A	N/A	X Walk 2 Width (in)	N/A
	X Walk 1 Slope (%)	2.7		X Walk 2 Slope (%)	3.7
	X Walk 1 X Slope (%)	4.9		X Walk 2 X Slope (%)	0.9

N/A	Ramp inside XWalk1?	N/A	N/A	Ramp inside XWalk2?	N/A
	Road Slope (%)	3.5	N/A	Clear Space?	N/A
	Road X Slope (%)	5.0	N/A	Clear Space to XWalk (in)	N/A
N/A	Any Obstructions?	N/A	N/A	Storm Grate/Utility Hazard?	N/A
	Obstruction Type			Storm Grate/Utility Type	
		N/A			N/A
		Yes		Surface Condition? (G/P)	Good

**Remove & Replace Curb Ramp With Two New Directional Ramps or Equivalent.**
