Access Compliance Report Public Rights-of-Way (Curb Ramps)

Cross Street: CANTERBURY CASTLE DR Intersection ID: 53743 Main Street: SMITH RD Location: NE **Severity Score: ADA ID: 795FB82FE11C** Ramp Type: Perp Initial Pass/Fail: Fail **Overall Compliance: No** 8.75

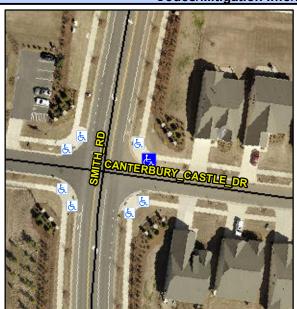
וע	Fossible Solution			i lelu ivie
1	Possible Solutions:	Compli	ance	Description
	Remove & Replace Entire Ramp.	N/A	Ramp	Length (in)
	•	No	Ramp	Width (in)
1		N/A	Flare	Type LT
		N/A	Flare	Slope LT (%)
1		N/A	Flare	Traversable LT
7		N/A	Landir	ng Length (in)
E In	Surveyor Notes:	N/A	Landir	ng Width (in)
The second	N/A	N/A	Landir	ng Slope (%)
5		N/A	Landir	ng X Slope (%
		N/A	Landir	ng Curb? (Y/N
100		N/A	Share	d Landing?
Į	PROW/ADA:	N/A	Gutte	Ponding?
Ì	R304.5.1	N/A	Gutter	Lip Ht (in)
9		N/A	Painte	ed X Walk1?
V			X Wal	k 1 Direction
Total Section		N/A	X Wal	k 1 Width (in)
			X Wal	k 1 Slope (%)
			X Wal	k 1 X Slope (%
		N/A	Ramp	inside XWalk1
