# Access Compliance Report

## Public Rights-of-Way

### (Curb Ramps)

| Intersection ID: 12150 | Main Street: W MARTIN LUTHER KING JR BLVD | Cross Street: S GRAHAM ST | Location: W |

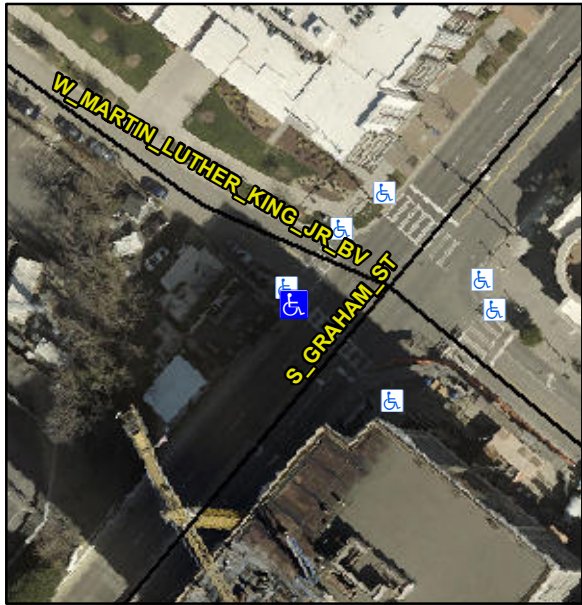
| ADA ID: 7961F813900E | Ramp Type: Perp | Initial Pass/Fail: Fail | Overall Compliance: No |

| Codes/Mitigation Info/Possible Solution | | | Field Measurements/Component Compliance | | | | | |
|---|---|---|---|---|---|---|---|---|
| | | | Yes | Ramp Width (in) | 58.0 | No | Ramp XSlope (%) | 8.7 |
| Not Found, R304.5.3 | | | N/A | Gutter Ponding? | N/A | N/A | Gutter Slope (%) | N/A |

| Codes/Mitigation Info/Possible Solution | | | Field Measurements/Component Compliance | | | | | |
|---|---|---|---|---|---|---|---|---|
| | Remove & Replace Entire Ramp. | | N/A | Ramp Length (in) | 62.0 | Yes | Ramp Slope (%) | 8.0 |
| Total Cost: | | \$ 1850.00 | | | | | | |
