Access Compliance Report

Public Rights-of-Way

(Curb Ramps)

Intersection ID: 10077	Main Street: E_35TH_ST	Cross Street: N_DAVIDSON_ST	Location: SW
ADA ID: 7968CD0CFC2C	Ramp Type: BlendTrans2	Initial Pass/Fail: Pass	Overall Compliance: No
		Severity Score: 7.5	
Codes/Mitigation Info/Possible Solution		Field Measurements/Component Compliance

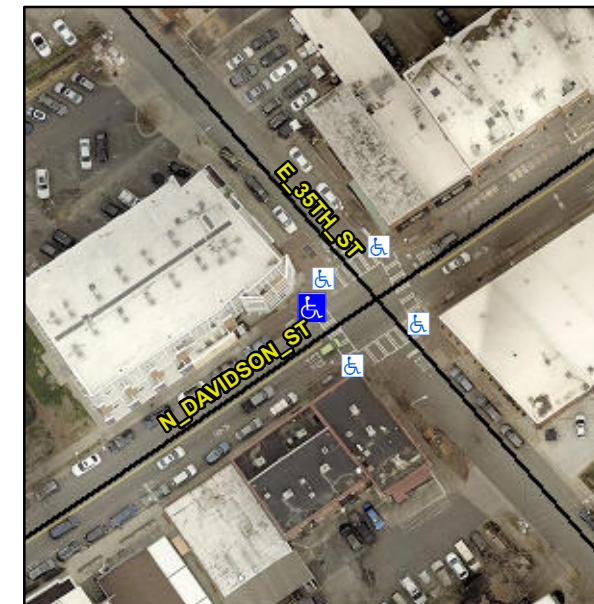
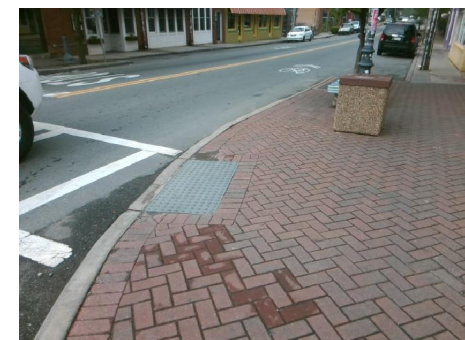
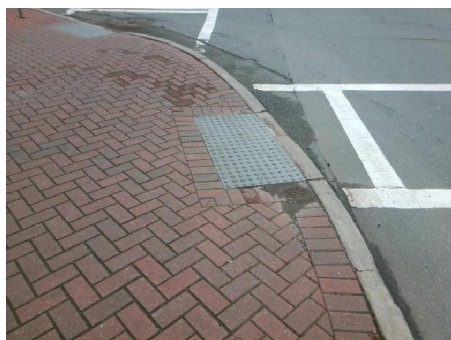
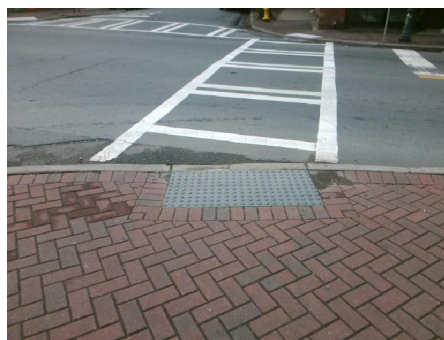
R304.2.3, R302.7.2

Compliance	Description	Data	Compliance	Description	Data
N/A	Ramp Length (in)	76.0	Yes	BlendTrans Slope (%)	4.5
Yes	Ramp Width (in)	48.0	Yes	BlendTrans XSlope (%)	0.7
N/A	Flare Type LT	Sloped	N/A	Flare Type RT	Sloped
No	Flare Slope LT (%)	N/A	No	Flare Slope RT (%)	N/A
N/A	Flare Traversable LT?	Yes	N/A	Flare Traversable RT?	Yes
N/A	Landing Length (in)	N/A	Yes	DWS Provided?	Yes
N/A	Landing Width (in)	N/A	Yes	DWS Contrast?	Yes
N/A	Landing Slope (%)	N/A	Yes	DWS Length (in)	24.0
N/A	Landing X Slope (%)	N/A	Yes	DWS Full Width?	Yes
N/A	Landing Curb? (Y/N)	No	Yes	DWS Offset (in)	0.0
N/A	Shared Landing?	No			
Yes	Gutter Ponding?	No	Yes	Gutter Slope (%)	1.7
No	Gutter Lip Ht (in)	0.3	Yes	Gutter X Slope (%)	1.1
N/A	Painted X Walk1?	Yes	N/A	Painted X Walk2?	N/A
	X Walk 1 Direction	To SE		X Walk 2 Direction	N/A
	X Walk 1 Width (in)	74.0		X Walk 2 Width (in)	N/A
	X Walk 1 Slope (%)	2.0		X Walk 2 Slope (%)	N/A
	X Walk 1 X Slope (%)	1.9		X Walk 2 X Slope (%)	N/A

Yes	Ramp inside XWalk1?	Yes	N/A	Ramp inside XWalk2?	N/A
	Road Slope (%)	1.9		Clear Space?	Yes
	Road X Slope (%)	2.0	N/A	Clear Space to XWalk (in)	N/A
Yes	Any Obstructions?	No	Yes	Storm Grate/Utility Hazard?	No
	Obstruction Type			Storm Grate/Utility Type	
		N/A			N/A
			Yes	Surface Condition? (G/P)	Good
			Yes	Curb Slope (%)	0.5

Remove & Replace Curb Ramp With Two New Directional Ramps or Equivalent. Grind Gutter Lip.
