Access Compliance Report

Public Rights-of-Way

(Curb Ramps)

Intersection ID: 49925	Main Street: PAXTON_RUN_RD	Cross Street: CAMPBELL_HALL_CT	Location: SE
ADA ID: 7977BF94A18F	Ramp Type: Perp	Initial Pass/Fail: Fail	Overall Compliance: No
Codes/Mitigation Info/Possible Solution		Field Measurements/Component Compliance	
Severity Score: 13.75

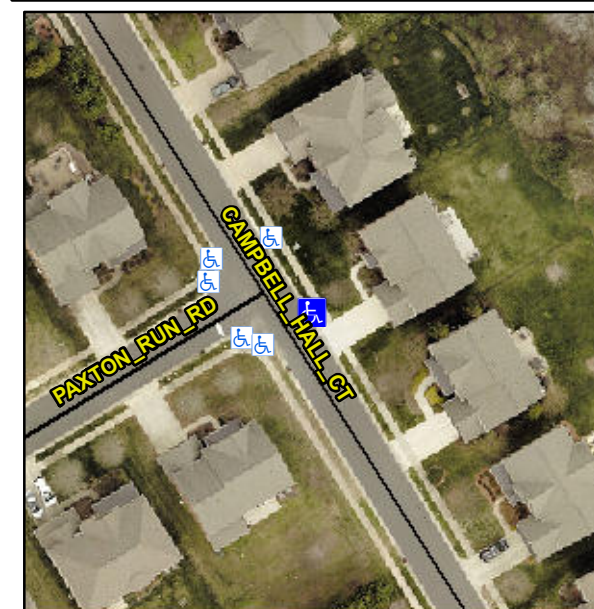
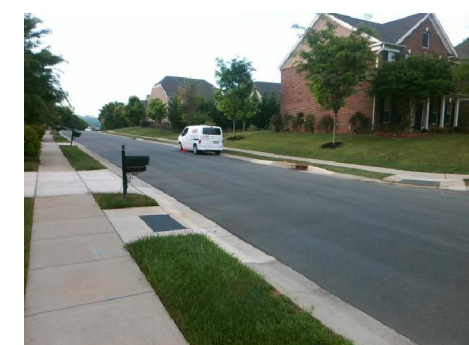
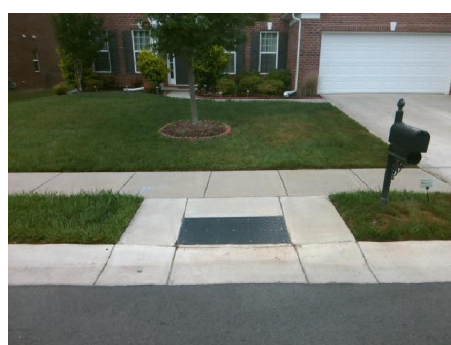
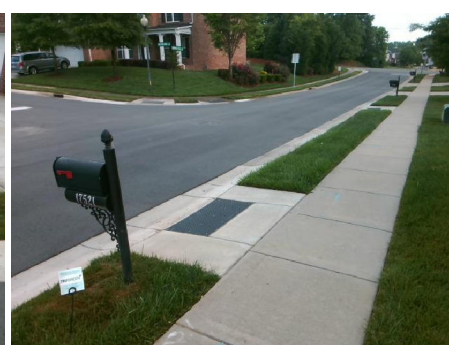
Not Found, R304.2.2, R304.5.3

Compliance	Description	Data	Compliance	Description	Data
N/A	Ramp Length (in)	47.0	No	Ramp Slope (%)	8.6
Yes	Ramp Width (in)	48.0	No	Ramp XSlope (%)	2.3
N/A	Flare Type LT	N/A	N/A	Flare Type RT	N/A
N/A	Flare Slope LT (%)	N/A	N/A	Flare Slope RT (%)	N/A
N/A	Flare Traversable LT?	N/A	N/A	Flare Traversable RT?	N/A
N/A	Landing Length (in)	N/A	N/A	DWS Provided?	N/A
N/A	Landing Width (in)	N/A	N/A	DWS Contrast?	N/A
N/A	Landing Slope (%)	N/A	N/A	DWS Length (in)	N/A
N/A	Landing X Slope (%)	N/A	N/A	DWS Full Width?	N/A
N/A	Landing Curb? (Y/N)	N/A	N/A	DWS Offset (in)	N/A
N/A	Shared Landing?	N/A			
N/A	Gutter Ponding?	N/A	N/A	Gutter Slope (%)	N/A
N/A	Gutter Lip Ht (in)	N/A	N/A	Gutter X Slope (%)	N/A
N/A	Painted X Walk1?	No	N/A	Painted X Walk2?	N/A
	X Walk 1 Direction	To SW		X Walk 2 Direction	N/A
N/A	X Walk 1 Width (in)	N/A	N/A	X Walk 2 Width (in)	N/A
	X Walk 1 Slope (%)	2.6		X Walk 2 Slope (%)	N/A
	X Walk 1 X Slope (%)	0.5		X Walk 2 X Slope (%)	N/A

N/A	Ramp inside XWalk1?	N/A	N/A	Ramp inside XWalk2?	N/A
	Road Slope (%)	N/A	N/A	Clear Space?	N/A
	Road X Slope (%)	N/A	N/A	Clear Space to XWalk (in)	N/A
N/A	Any Obstructions?	N/A	N/A	Storm Grate/Utility Hazard?	N/A
	Obstruction Type			Storm Grate/Utility Type	
		N/A			N/A
			Yes	Surface Condition? (G/P)	Good

Remove & Replace Entire Ramp.

Total Cost: \$ 1850.00
