# Access Compliance Report

## Public Rights-of-Way

### (Curb Ramps)

Intersection ID: 14067	Main Street: GREENWAY_AV	Cross Street: PARK_DR	Location: SW
ADA ID: 7994017FC409	Ramp Type: PerpDiag	Initial Pass/Fail: Fail	Overall Compliance: No
Codes/Mitigation Info/Possible Solution		Field Measurements/Component Compliance	
Severity Score: 37.5

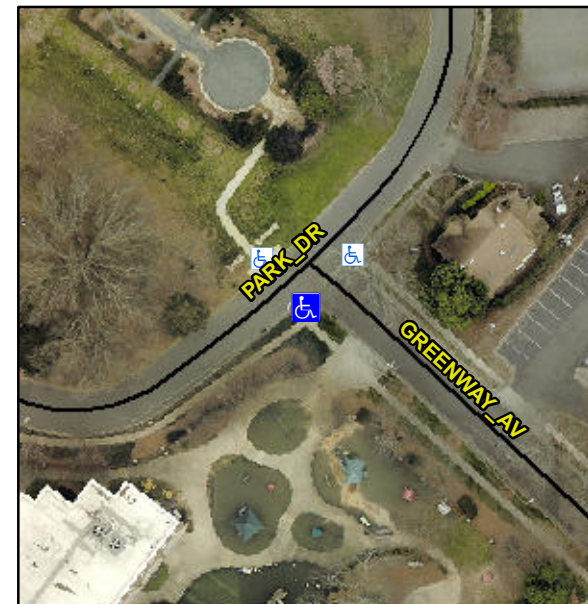
**Not Found, R304.2.2, R304.5.3**

Compliance	Description	Data	Compliance	Description	Data
N/A	Ramp Length (in)	118.0	No	Ramp Slope (%)	14.6
Yes	Ramp Width (in)	60.0	No	Ramp XSlope (%)	5.2
N/A	Flare Type LT	N/A	N/A	Flare Type RT	N/A
N/A	Flare Slope LT (%)	N/A	N/A	Flare Slope RT (%)	N/A
N/A	Flare Traversable LT?	N/A	N/A	Flare Traversable RT?	N/A
N/A	Landing Length (in)	N/A	N/A	DWS Provided?	N/A
N/A	Landing Width (in)	N/A	N/A	DWS Contrast?	N/A
N/A	Landing Slope (%)	N/A	N/A	DWS Length (in)	N/A
N/A	Landing X Slope (%)	N/A	N/A	DWS Full Width?	N/A
N/A	Landing Curb? (Y/N)	N/A	N/A	DWS Offset (in)	N/A
N/A	Shared Landing?	N/A			
N/A	Gutter Ponding?	N/A	N/A	Gutter Slope (%)	N/A
N/A	Gutter Lip Ht (in)	0.5	N/A	Gutter X Slope (%)	N/A
N/A	Painted X Walk1?	No	N/A	Painted X Walk2?	No
	X Walk 1 Direction	To NE		X Walk 2 Direction	To NW
N/A	X Walk 1 Width (in)	N/A	N/A	X Walk 2 Width (in)	N/A
	X Walk 1 Slope (%)	8.0		X Walk 2 Slope (%)	2.6
	X Walk 1 X Slope (%)	0.2		X Walk 2 X Slope (%)	3.4

**Remove & Replace Curb Ramp With Two New Directional Ramps or Equivalent.**

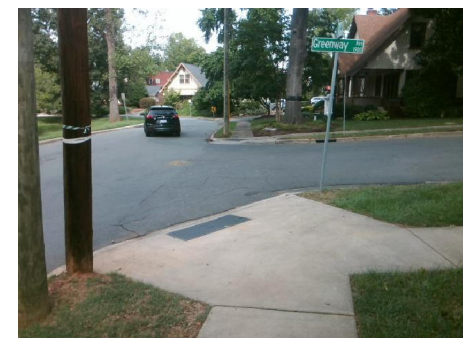
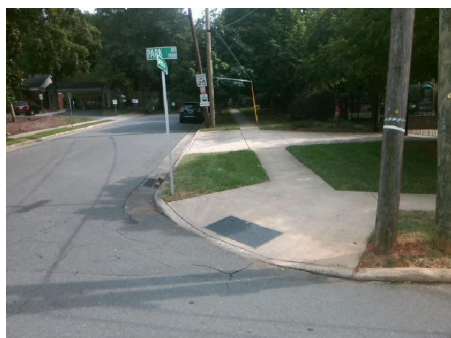
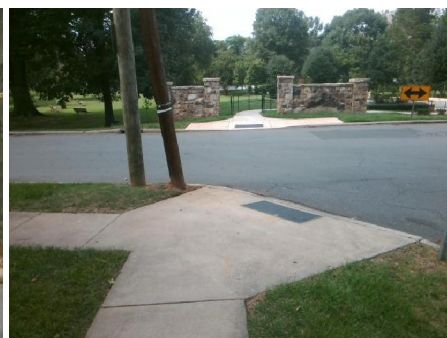
N/A	Ramp inside XWalk1?	N/A	N/A	Ramp inside XWalk2?	N/A
	Road Slope (%)	3.4	N/A	Clear Space?	N/A
	Road X Slope (%)	2.7	N/A	Clear Space to XWalk (in)	N/A
N/A	Any Obstructions?	N/A	N/A	Storm Grate/Utility Hazard?	N/A
	Obstruction Type			Storm Grate/Utility Type	
		N/A			N/A
		Yes		Surface Condition? (G/P)	Good
