Access Compliance Report

Public Rights-of-Way

(Curb Ramps)

Intersection ID: 13854	Main Street: E_PARK_AV	Cross Street: SOUTH_BV	Location: SE
ADA ID: 79950FA90C29	Ramp Type: BlendTrans1	Initial Pass/Fail: Fail	Overall Compliance: No
Codes/Mitigation Info/Possible Solution			Severity Score: 10
			Field Measurements/Component Compliance

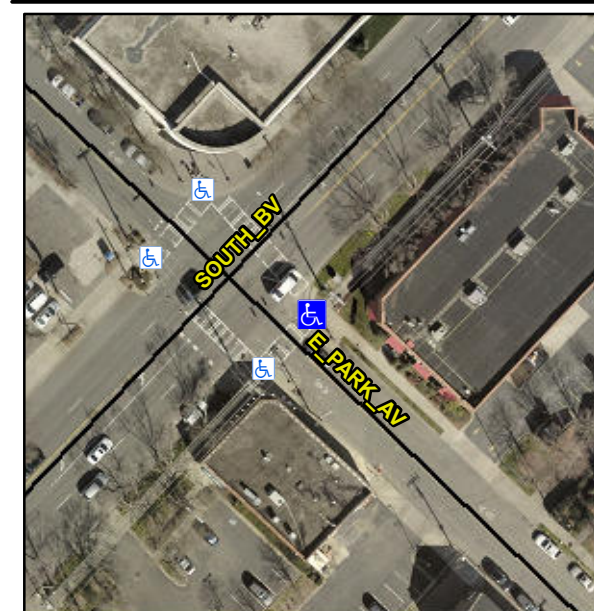
Not Found, R304.5.1, R304.5.3

Compliance	Description	Data	Compliance	Description	Data
N/A	Ramp Length (in)	41.0	Yes	BlendTrans Slope (%)	3.9
No	Ramp Width (in)	40.0	No	BlendTrans XSlope (%)	3.7
N/A	Flare Type LT	N/A	N/A	Flare Type RT	N/A
N/A	Flare Slope LT (%)	N/A	N/A	Flare Slope RT (%)	N/A
N/A	Flare Traversable LT?	N/A	N/A	Flare Traversable RT?	N/A
N/A	Landing Length (in)	N/A	N/A	DWS Provided?	N/A
N/A	Landing Width (in)	N/A	N/A	DWS Contrast?	N/A
N/A	Landing Slope (%)	N/A	N/A	DWS Length (in)	N/A
N/A	Landing X Slope (%)	N/A	N/A	DWS Full Width?	N/A
N/A	Landing Curb? (Y/N)	N/A	N/A	DWS Offset (in)	N/A
N/A	Shared Landing?	N/A			
N/A	Gutter Ponding?	N/A	N/A	Gutter Slope (%)	N/A
N/A	Gutter Lip Ht (in)	N/A	N/A	Gutter X Slope (%)	N/A
N/A	Painted X Walk1?	Yes	N/A	Painted X Walk2?	Yes
	X Walk 1 Direction	To NW		X Walk 2 Direction	To SW
	X Walk 1 Width (in)	114.0		X Walk 2 Width (in)	109.0
	X Walk 1 Slope (%)	4.4		X Walk 2 Slope (%)	6.5
	X Walk 1 X Slope (%)	4.2		X Walk 2 X Slope (%)	1.1

N/A	Ramp inside XWalk1?	Yes	N/A	Ramp inside XWalk2?	Yes
	Road Slope (%)	0.8		Clear Space?	N/A
	Road X Slope (%)	7.1	N/A	Clear Space to XWalk (in)	N/A
N/A	Any Obstructions?	N/A	N/A	Storm Grate/Utility Hazard?	N/A
	Obstruction Type			Storm Grate/Utility Type	
		N/A			N/A
			Yes	Surface Condition? (G/P)	Good
			No	Curb Slope (%)	6.2

Possible Solutions:

Remove & Replace Curb Ramp With Two New Directional Ramps or Equivalent.
