Access Compliance Report

Public Rights-of-Way (Curb Ramps)

Intersection ID: 10040084	Main Street: TUCKASEEGEE_RD	Cross Street: N/A	Location: S
ADA ID: 7997780D9879	Ramp Type: Directional1	Initial Pass/Fail: Fail	Overall Compliance: No
		Severity Score: 25

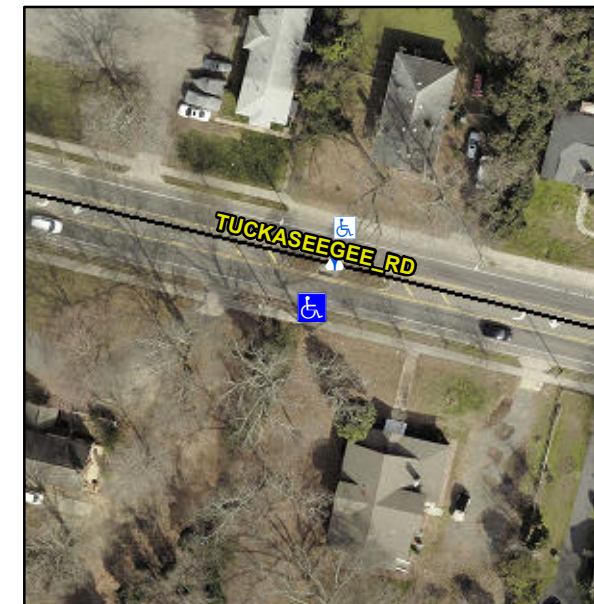
Compliance	Description	Data	Compliance	Description	Data
N/A	Ramp Length (in)	49.0	N/A	Grade Break?	N/A
Yes	Ramp Width (in)	48.5	N/A	Grade Break Slope (%)	0.0
No	Ramp Slope (%)	13.7	N/A	Grade Break XSlope (%)	0.0
Yes	Ramp XSlope (%)	1.7			
N/A	Flare Type LT	N/A	N/A	Flare Type RT	N/A
N/A	Flare Slope LT (%)	N/A	N/A	Flare Slope RT (%)	0.0
N/A	Flare Traversable LT?	N/A	N/A	Flare Traversable RT?	N/A
N/A	Landing Length (in)	0.0	N/A	DWS Provided?	N/A
N/A	Landing Width (in)	0.0	N/A	DWS Contrast?	N/A
N/A	Landing Slope (%)	0.0	N/A	DWS Length (in)	N/A
N/A	Landing X Slope (%)	0.0	N/A	DWS Full Width?	N/A
N/A	Landing Curb? (Y/N)	N/A	N/A	DWS Offset LT (in)	N/A
N/A	Shared Landing?	N/A	N/A	DWS Offset RT (in)	N/A
N/A	Gutter Ponding?	0.0	N/A	Gutter Slope (%)	N/A
N/A	Gutter Lip Ht (in)	0.0	N/A	Gutter X Slope (%)	N/A
N/A	Painted X Walk1?	No		Road Slope (%)	6.5
	X Walk 1 Direction	To N		Road X Slope (%)	2.3
	X Walk 1 Width (in)	N/A		Clear Space?	N/A

X Walk 1 Slope (%)	6.5	N/A	Clear Space to XWalk (in)	N/A
	X Walk 1 X Slope (%)	2.3	N/A	Storm Grate/Utility Hazard?	N/A
N/A	Ramp inside XWalk1?	N/A		Storm Grate/Utility Type	
N/A	Any Obstructions?	N/A			N/A
	Obstruction Type		Yes	Surface Condition? (G/P)	Good
			N/A	Curb Slope (%)	17.9

Remove & Replace Entire Ramp.
